## Consulting Report Breaker Trip / Fuse Blowing Investigation MCC / Blower Motors

### Introduction / Background

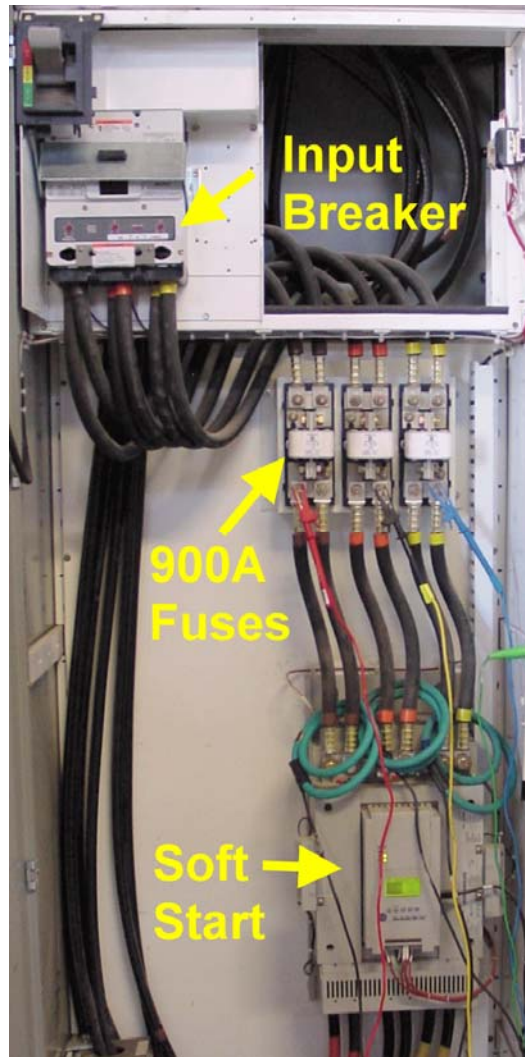
The plant had recently completed installation of four new blowers as well as a new electrical service; associated switchgear and automatic transfer switch (ATS). Following installation blowers 3 and 4 served from MCC 3 and MCC 4 respectively, experienced several failures of phase A fuse and a breaker operation of the associated 600A MCC input breaker.

Photo 1 shows the MCC cabinet components—main input circuit breaker, fuses (phase A which has blown several times) and the soft-start.

**Photo 1 - MCC cabinet showing components.**

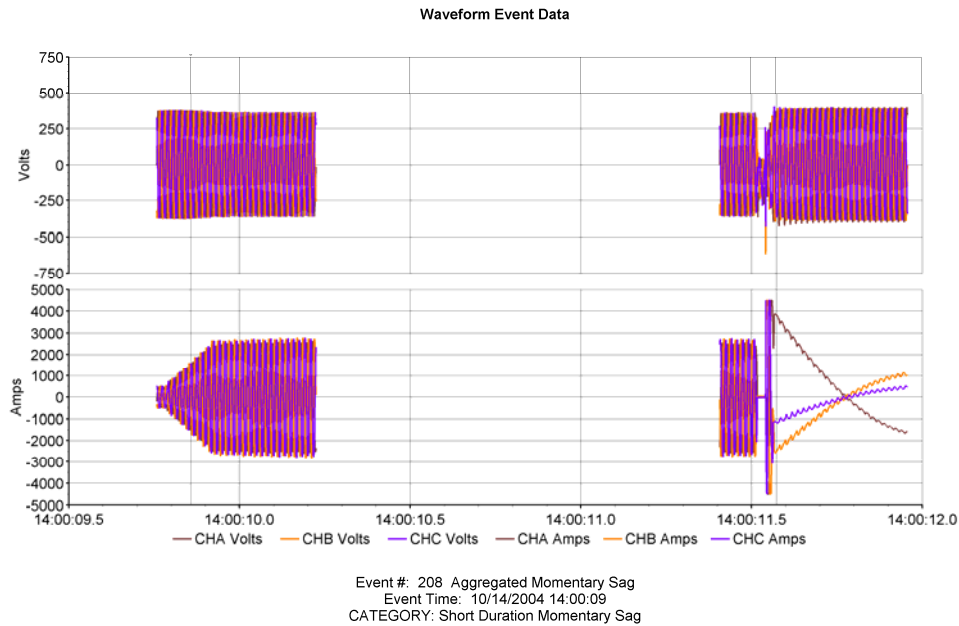
Figure 5 shows the waveform envelope associated with blower 4 tripping off at the time blower 3 was being started. Careful analysis of the waveforms indicates that after about 1.7-seconds (100-cycles)

something causes the Automatic Transfer Switch (ATS) switch to transfer to the alternate (second) source. At the time that the ATS closes on the second source a current surge, well above the instantaneous setting of 3000A for the MCC 600A input breaker, is experienced causing the 600A breaker in the MCC to trip.

**Figure 5 – Waveform envelop at load side of ATS showing open transition and current surge associated with second source.**

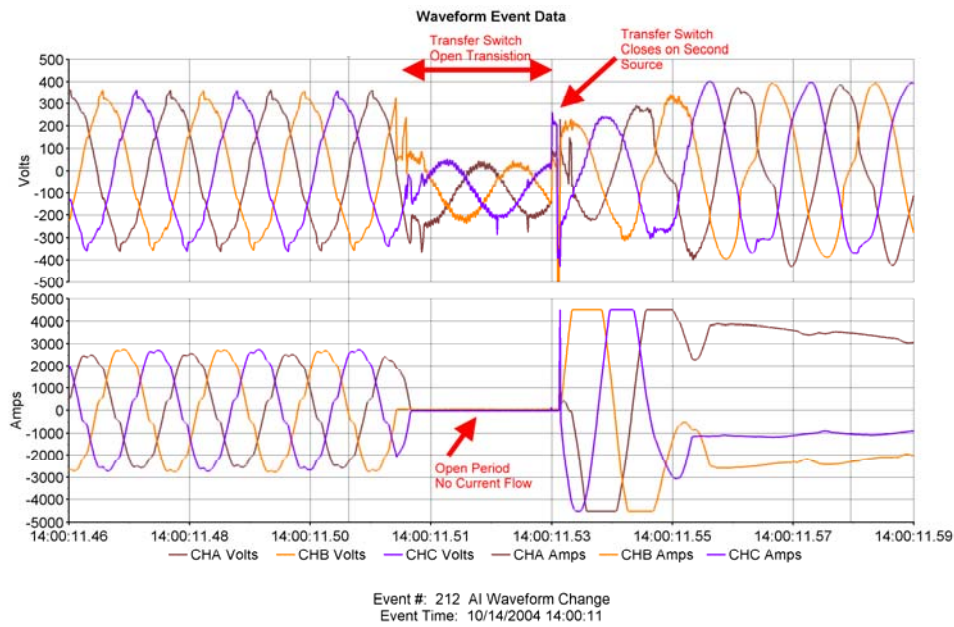
**Figure 6 – Detailed waveform from figure 5 showing open transition and connection to second source.**

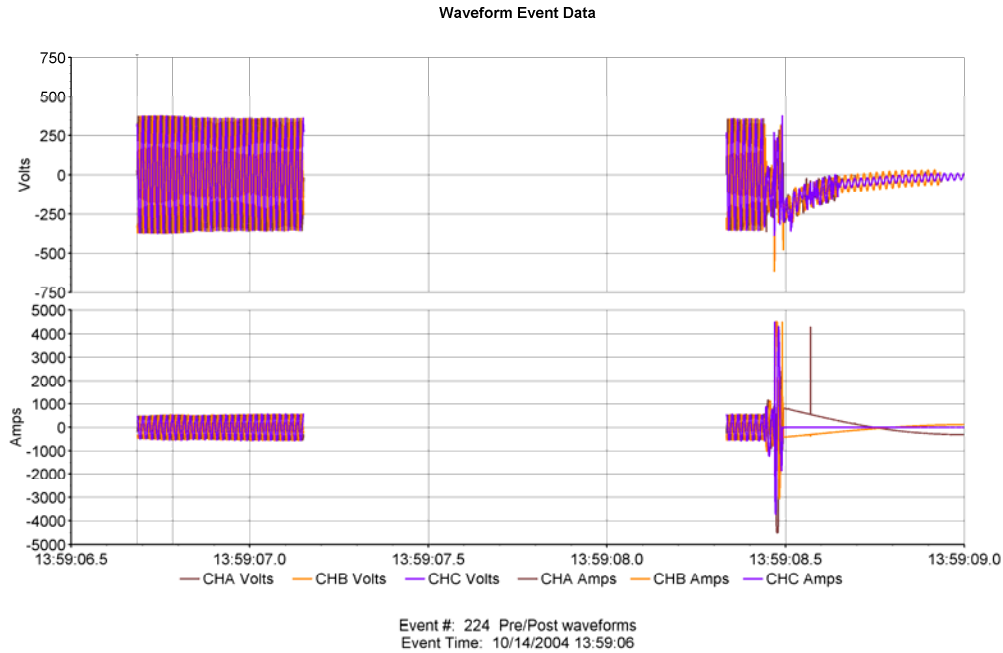
**Figure 7 - Waveform envelop from MCC 4 at the time blower 3 was attempting to start. Note 4000+ Amp current surge that operated MCC 4 600A input breaker.**

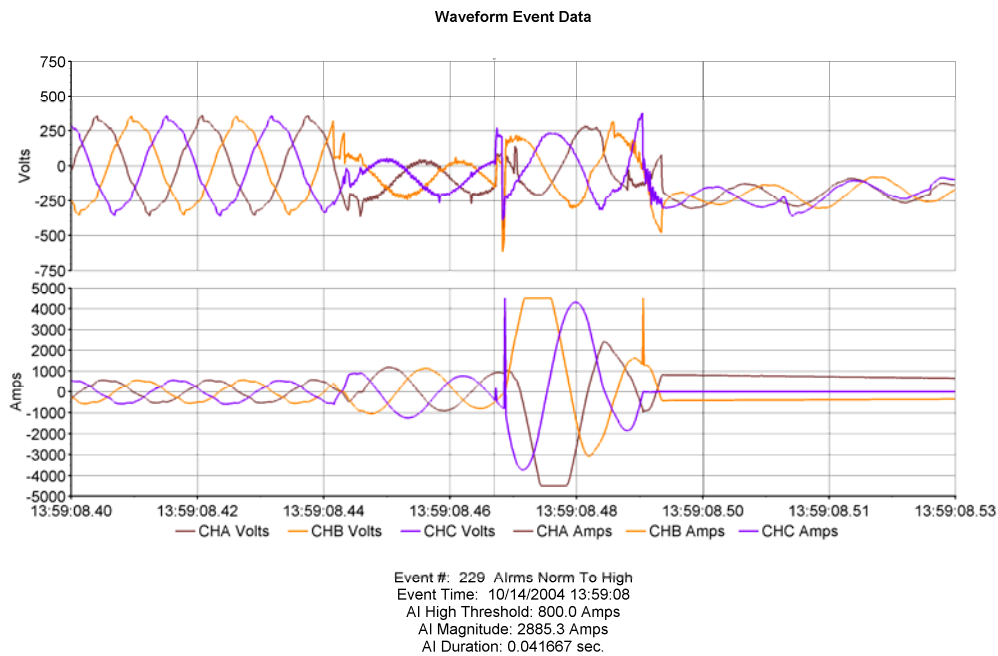
**Figure 8 – Detailed waveform from figure 7 showing 4000+ Amp current surge.**

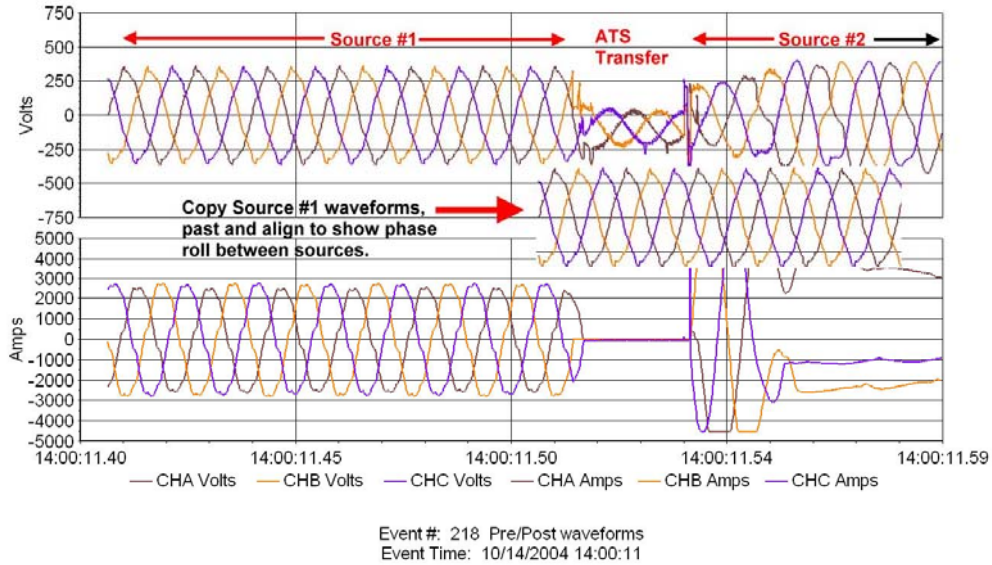
Careful analysis of the event waveforms recorded during the breaker tripping revealed that there appeared to be phase transposition (rotation/rolling) between the two sources—north and south utility feeds—connected to the ATS.

**Figure 12 – Detailed waveform event data from failed start-up and breaker trip showing phasing problem between ATS sources. (Waveforms from source #1 were copied, pasted and aligned to better illustrate phase “roll” between sources).**

The ATS is set for “rapid” transfer—one-cycle open transition—and with the phase inconsistencies between the sources and the inductive (magnetic) nature of the load, the load is going to react adversely to the application of an out of phase stiff voltage source resulting in large current surges which are well above 4000A.

**RECOMMENDATION:** (1) Correct the phase inconsistencies between the respective sources of the ATS. It is actually more like the phases were “rolled” (or rotated) as the correction involves all three-phases. The inconsistency could be in either of the sources (services) or the actual wiring of the ATS. While it is common practice to verify phase rotation it is no guarantee that the ATS inputs are wired with the proper phase relationships—as this experience demonstrates. Phase rotation should always be checked, and in addition a voltage reading should be made between corresponding phases of the respective sources—a near zero value should be obtained if the phase relationships are correct. In the case of the new ATS the readings of A to A, B to B and C to C were all in the 480V range indicating a phase relationship wiring problem. (2) Retest and document cycling of equipment in various modes following correction of ATS wiring.

**CORRECTIVE ACTION / DISPOSITION:** The Utility Department rolled the phases associated with the south feed transformer to correct the phase inconsistencies between the sources of the new ATS. A Dranetz-BMI PowerGuide 4400 was connected to each source of the new ATS to verify correct phase relationships and phase rotation after completion.

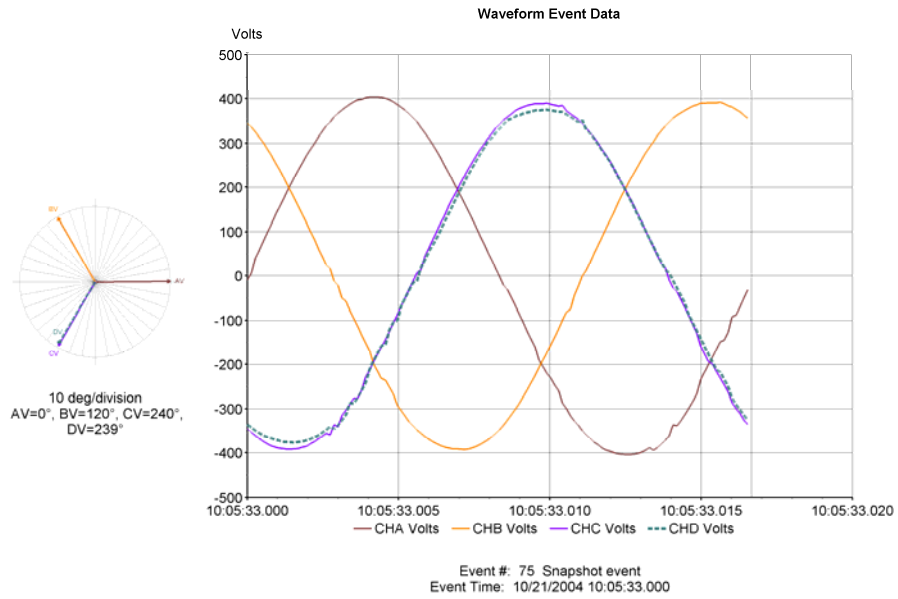
The results of the testing determined that while the phase rotation (ACB) is the same for both sources the relationship of the phases across the ATS is rotated 120-degrees. Figure 13 is a waveform graphic with phasor showing that phase A of source #1 is related to phase C on source #2. Photo 2 shows the relative ATS phase relationships for source #1 and #2.

Figure 13 – Voltage waveforms associates with ATS source #2 with channel D connected to phase A of ATS source #1 which tracks with phase C of source #2.

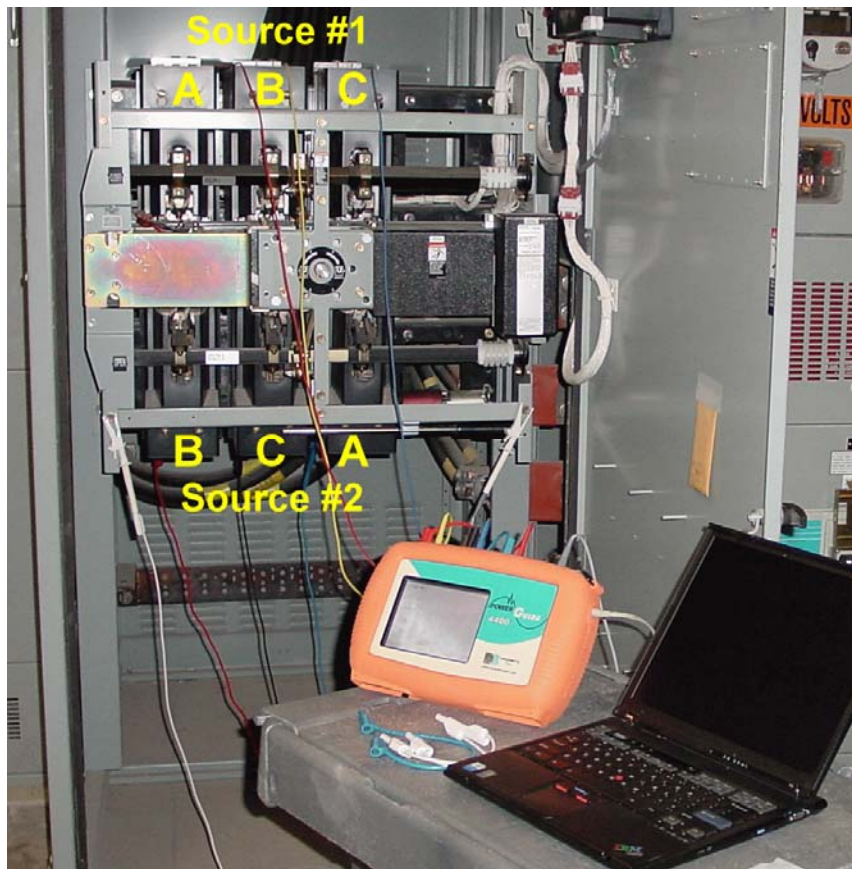
Photo 2 - New transfer switch showing phase termination rotation between sources.

There is a high likelihood that the blown fuse and breaker tripping experienced earlier are related to the wiring error associated with the new ATS. Both the ATS and the controller (PLC) for each blower have various thresholds settings and they may be set a little sensitive for this application and certainly need to be coordinated.
