Consulting Report ATE Product Testing Lab Noise Problem ABC Industries Somewhere Valley, AK

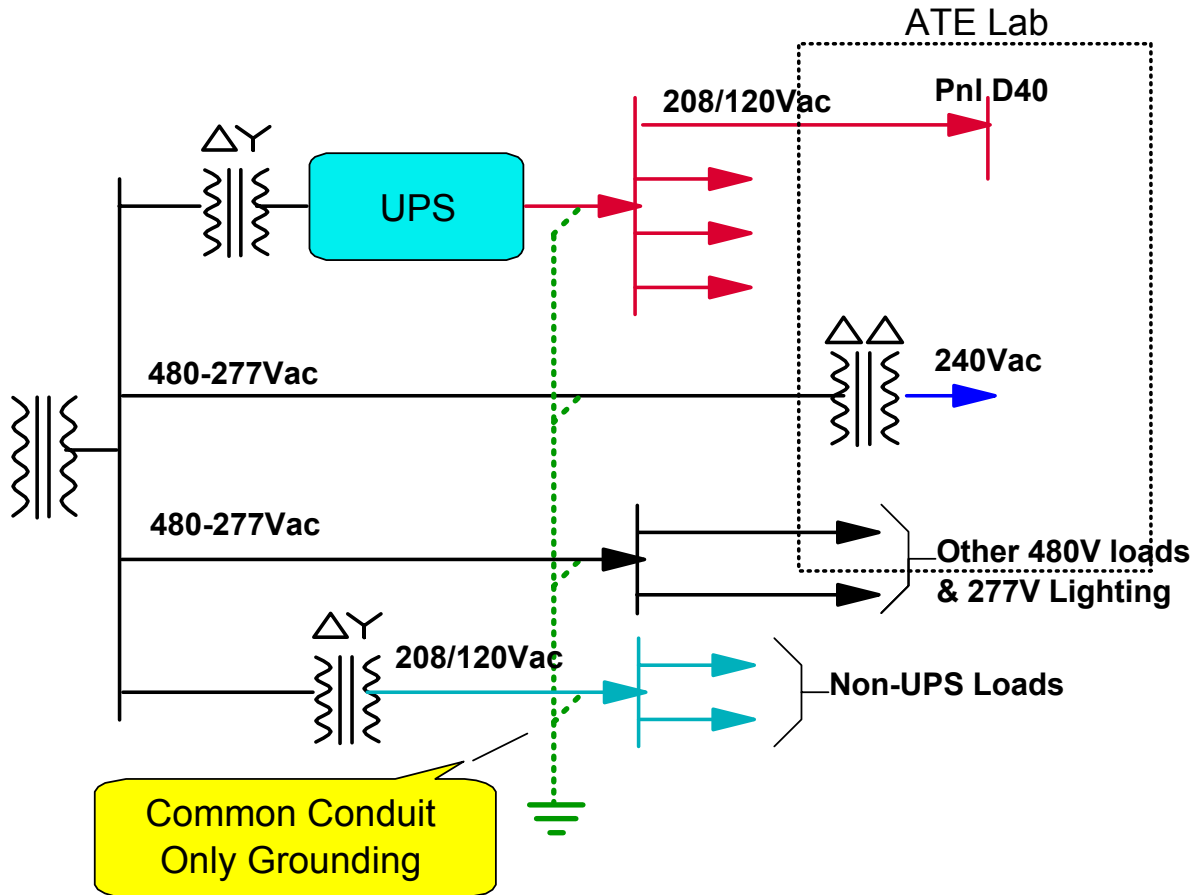
Figure 1 is a graphical attempt to illustrate present grounding and distribution system with common conduit connection. The mounting brackets for the conduit are common which effectively ties all electrical systems together through the building. The result is that interference generated anywhere in the building has the potential to flow through the various conduits in the ATE Lab area.

In addition the integrity of the equipment grounding system is dependent on the various physical connection methods used in the construction of the electrical system—screw thread, clamp, compression sleeve, etc. All of these methods of connection have their problems and should never be used as the sole grounding means in an electronic installation.

Figure 1 - ABC facility electrical distribution--conduit only grounding.

All future construction specifications for the buildings electrical distribution system should specify that appropriately sized ground conductors be installed in all conduits along with the current carrying conductors. This serves two purposes: (1) in the event of electrical faults on an associated circuit the equipment grounding conductor will carry the highest level of fault current and limit (lower) the propagation of interference signals in the remainder of the conduit system and (2) the quality of the equipment grounding system will be improved as the integrity of the system will no longer depend on screw-thread, clamp and compression sleeve connections as the only ground means.

Future building specifications for electronic environments should also include the requirement for equipment ground conductors—specifically, do not rely on conduit only grounding. Electrical distribution for all future construction should employ dry-type delta-wye distribution transformers to create zones of interest, and limit interference and zero-sequence harmonics from propagating throughout the buildings electrical distribution. The transformer requirement is especially critical for laboratory—ATE, Environmental, EMC, etc.—areas which all should be served from individual transformers. (See recommendation for ATE Lab below.)

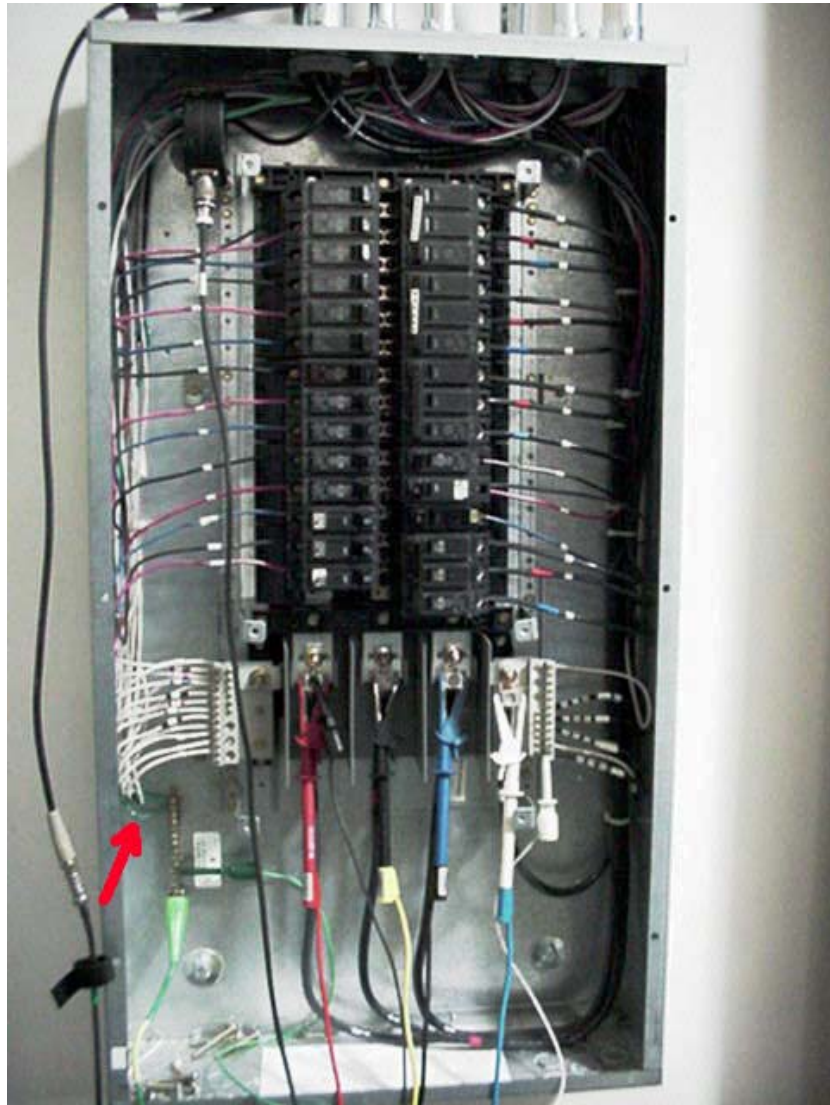
A visual inspection of panelboard D40 revealed circuits 22-24-26 were installed with a green-wire grounding conductor (isolated ground). The associated circuits terminated in the Environmental Lab across the hallway. Further inspection of the duplex receptacles installed on the circuits found one that was NOT an Isolated Ground (IG) type and this resulted in connection of the conduit grounding system with the Isolated Ground conductor terminated in D40. (Facility electricians removed the offending duplex receptacle at approximately 3:10PM on 4/27/2000.)

Photo 1 below shows the offending green wire IG conductor—red arrow. (See recommendations for practices regarding installation of branch circuits between zones.)

Photo 1- Panelboard D40 ATE Lab showing green wire IG conductor terminating in Environmental Lab across the hallway.

The practice of installing branch circuits where they originate in one lab (sensitive area) and terminate in another lab—as was the case with the IG circuits 22-24-26 in panelboard D40 (ATE Lab)—should be avoided. Installing circuits, which run between zones of interest compromise the electrical integrity (at least from an interference standpoint) of both lab areas.

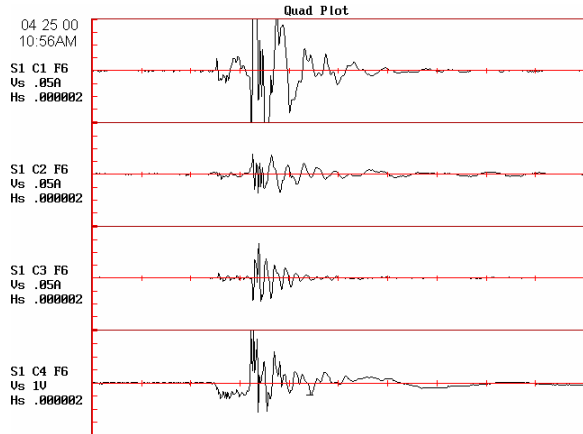
Figure 2 below shows one of the larger interference events recorded by the DSO during the initial monitoring period.

In Figure 2 channel 1 is the signal on the IG conductor that terminated on the receptacles from the Environmental lab the corresponding signals on the grounds, channels 2 and 3, associated with the TS4 test station demonstrate how the signal propagated in the conduit grounding system. Channel 4 is the corresponding neutral-to-ground voltage in the 5kHz-5MHz bandwidth.

Figure 2 - High frequency ground based interference. Ch1=Ground current in D40-Ckts 22-24-26 green wire ground; Ch2=Ground current in LT Flex to TS4; Ch3=Ground current in green wire in power panel of TS4; and Ch4=Neutral-to-Ground voltage in D40 (5kHz-5MHz bandwidth).

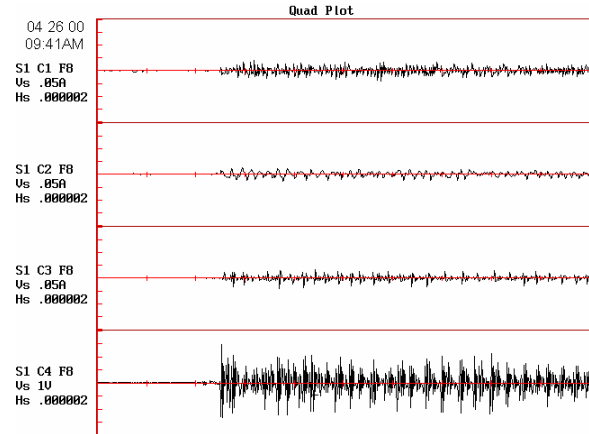
Figure 3 is an event, which was recorded at 9:41AM on 4/26/2000, and in this instance the monitoring system was connected to the XYZ/TS test station with channel 3 monitoring the TTL data link between the test station and the UUT (Unit Under Test). Again there are significant signals present on the other grounding conductors—channels 1 and 2—as well as a voltage signal recorded on channel 4—neutral-to-ground at panelboard D40. This signal is the type that has the capability to disrupt digital communications signals because of the duration and the burst (repetitive) characteristic. In all likelihood the path through the TTL link and UUT is capacitively coupled, as the signals appear to have higher frequency characteristics—shorter rise-times. (Note: This characteristic was noted in other recorded interference signals on the TTL data link.)

Figure 3 - High frequency ground based interference. Ch1=Ground current in D40-Ckts 22-24-26 green wire ground; Ch2=Ground current in LT Flex to XYZ/TS; Ch3=Interference signals in TTL data link between test equipment and UUT in XYZ/TS; and Ch4=Neutral-to-Ground voltage in D40 (5kHz-5MHz bandwidth).

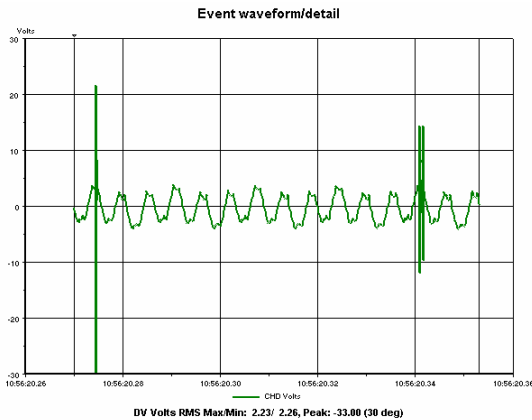
The Dranetz-BMI 658 Power Quality also recorded a series of neutral-to-ground voltage impulses at the same time as the event in Figure 2, the largest of which was approximately 51 volts peak-to-peak—see Figures 4 and 5. Figure 4 is the neutral-to-ground event and Figure 5 is an expansion of the largest of the impulses in Figure 4. There was not a corresponding line-to-neutral event recorded which indicates that the signal is ground based—HF current probes confirm the current flowing in the various grounding conductors and conduit.

Figure 4 - Neutral-to-ground power monitor event corresponding to signals in Figure 2.

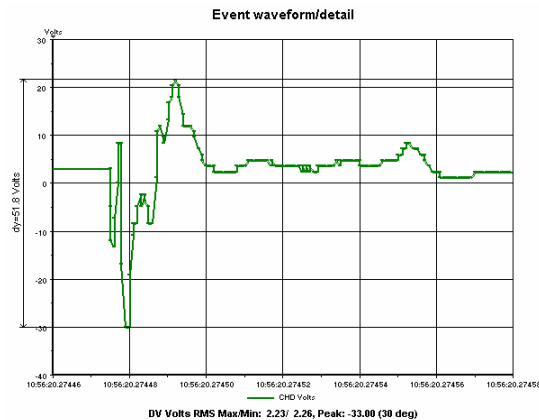
Figure 5 - Expanded neutral-to-ground power monitor event depicted in Figure 4.

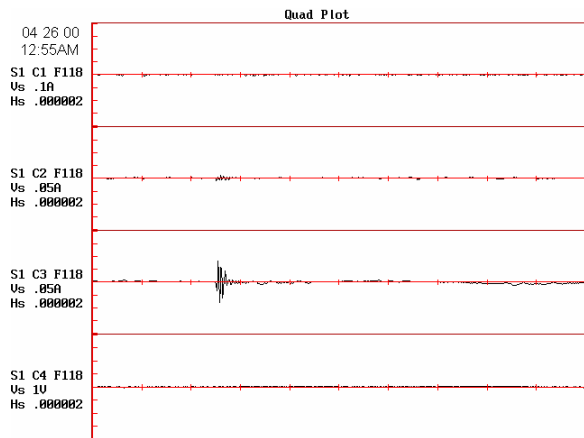
In Figure 6 the only significant signal recorded was on channel 3, which is the TTL data link on test station TS4. The graphic to the right, Figure 7, is an expansion of the signal on channel 3 from Figure 6. The ringing frequency of the recorded events ranged from approximately 5MHz to 8MHz and may be alisased. The lack of significant signals on the other channels indicates that the source of interference recorded on channel 3 may be in the test station equipment.

Figure 6 – Interference signal (current) on TTL data link TS4 test station.

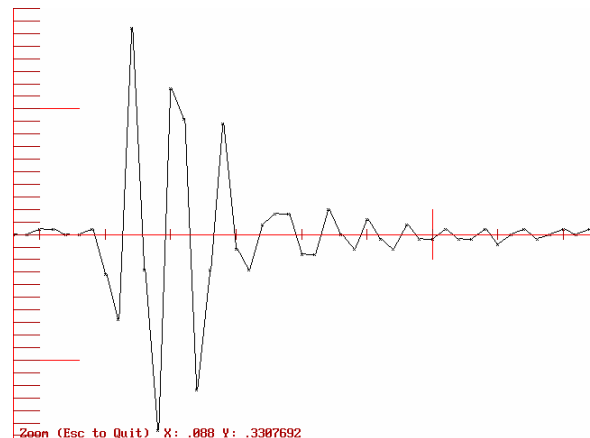
Figure 7 – Expansion of signal (current) on channel 3 from Figure 6—TTL data link.

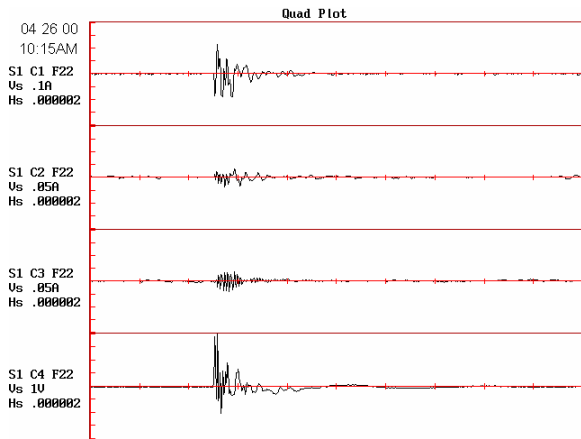
Figure 8 is a set of signals similar to those in Figures 2 and 3 in that they are entering the ATE Lab via the equipment grounding (conduit) system and then propagated throughout the area including the TTL data link. Figure 9 is an expansion of the signal on channel 3,

Figure 8 – Interference signals associated with ATE station TS4.

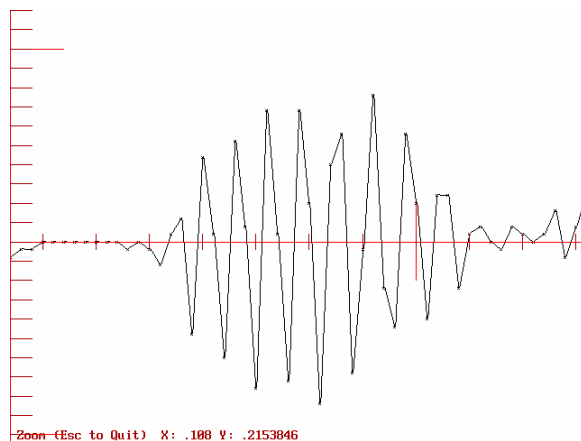
Figure 9 – Expanded interference signal, channel 3, TTL data link test station TS4.

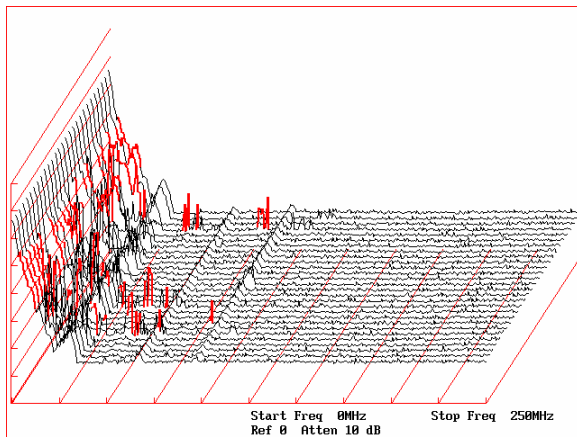
The following two figures, 10 and 11, are waterfall plots of the recorded data from the spectrum analyzer. Each trace represents a peak-hold from a 5-minute period of time. The red highlighted signals represent levels 10% above the average. The frequency spectrum (x-axis) events are grouped on the left side (lower frequency) and are consistent with the frequency characteristics of the recorded signals. (Note: The 3dB bandwidth of the current probe used is 10kHz to 100MHz so the few signals above 100 MHz are not represented accurately.)

Figure 10 – Spectrum analyzer waterfall plot from initial monitoring session on 4/25/2000.

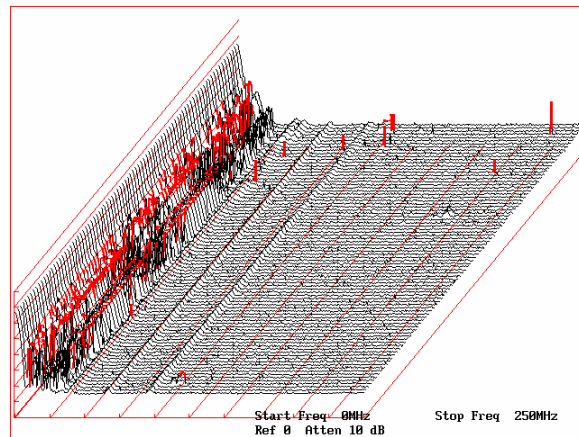
Figure 11 – Spectrum analyzer waterfall plot from 4/25/2000 @ 1:43PM through 4/26/2000 @ 9:43AM.

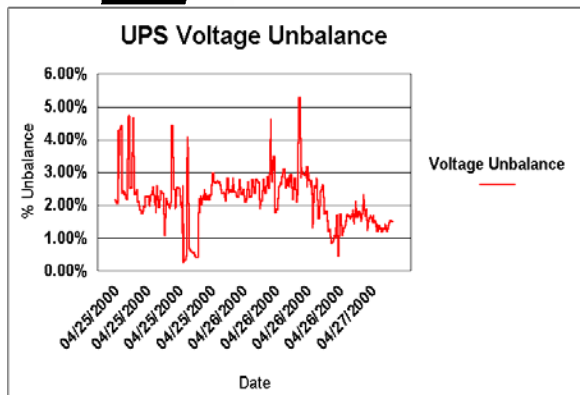
The following graphic, Figure 12, is a record of the phase voltage unbalance recorded at panelboard D40 in the ATE Lab area. Generally voltage unbalance levels above 3% are considered points where corrective action is recommended. Voltage unbalance as low as 2% can impact the operation of some motor drives. Higher levels of unbalance can cause premature electric motor failure or inconsistent operation.

Figure 12 – UPS voltage unbalance.

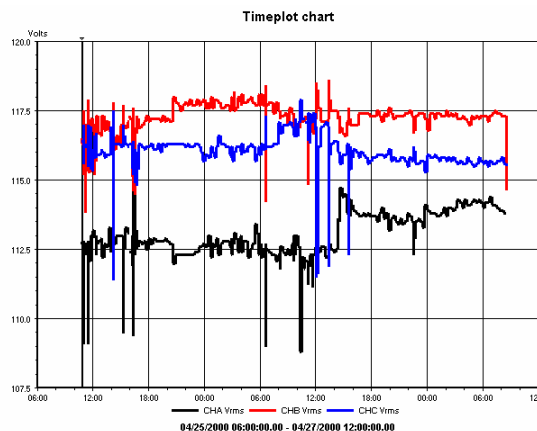
Figure 13 – RMS voltage timeplot.

Figure 13 (above) is a timeplot of the RMS voltage levels recorded at panelboard D40 over the duration of the monitoring period, which was the basis for the unbalance calculations illustrated in Figure 12.

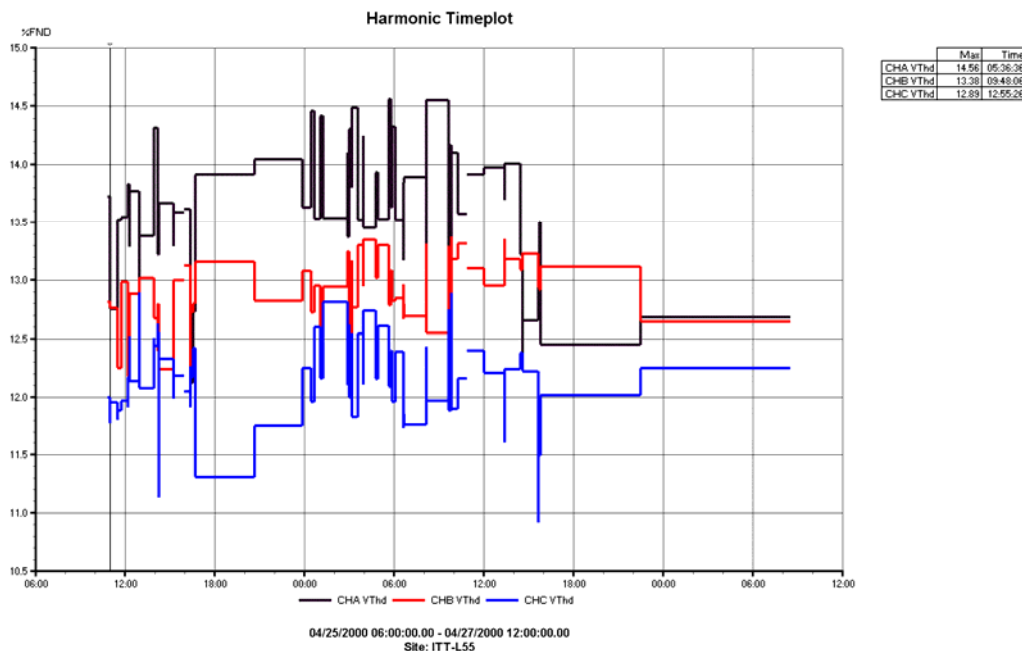
During the monitoring period the Vthd ranged from 11% to over 14%. A level of between 6% and 10% is generally considered the area where corrective action is recommended. The dominant cause of the voltage distortion is the load interaction between the single-phase switch-mode power supplies (computer type loads) and the output impedance of the UPS inverter section. Figure 14 is a timeplot of the voltage total harmonic distortion (THD) over the duration of the monitoring period. Figure 15 is a representative sample of the voltage waveform demonstrating both the phase unbalance and the waveform distortion.

Figure 14 – Voltage distortion timeplot.

- Inspect and test UPS output filter capacitors—infrared thermography can sometimes be used to ascertain the condition of the filter capacitors (look for the cold ones).
- Monitor and determine phase voltage unbalance levels at UPS output and verify load balance on major UPS distribution feeders.
- Review loads connected to UPS power system—remove non-critical loads that do not require UPS power.
- Monitor and determine harmonic content at UPS output—voltage and current.
- Based on findings from above activities develop a mitigation program to improve (decrease) harmonic voltage distortion and restore phase voltage balance.

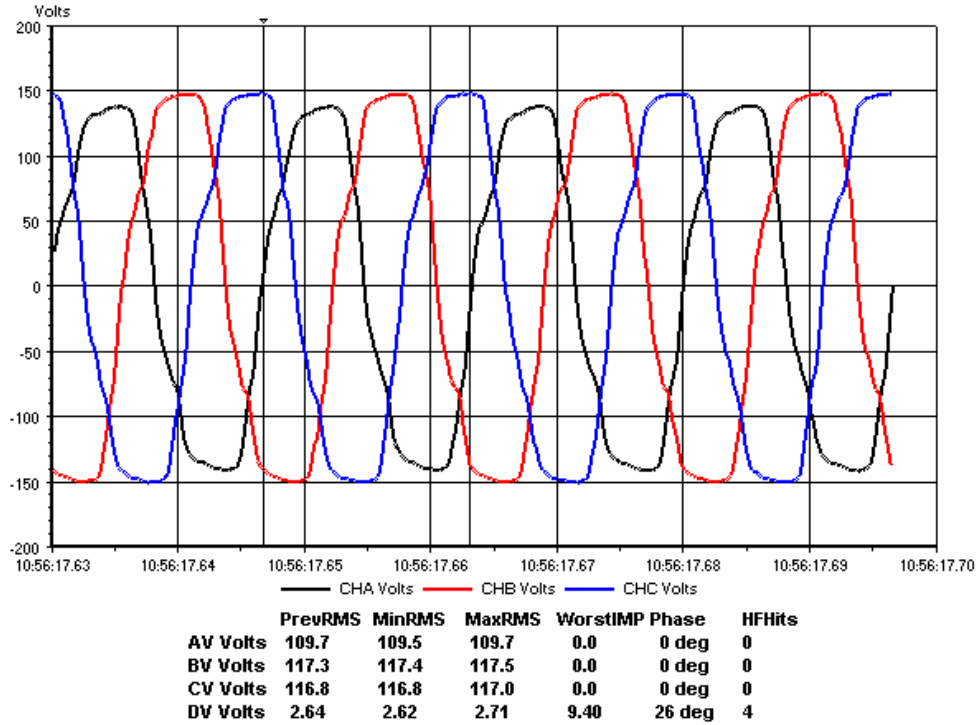
Figure 15 – Voltage waveforms showing phase unbalance and waveform distortion.

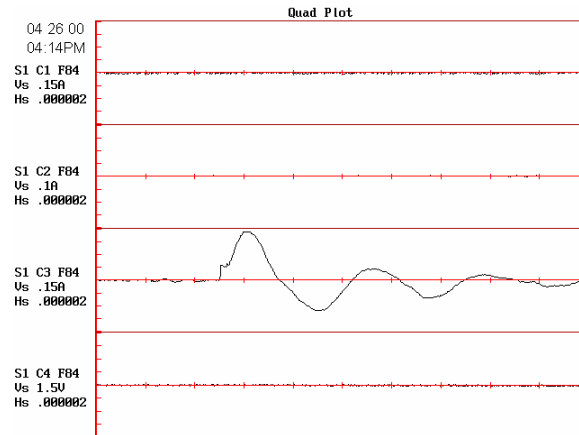
The following figure is a recording of the current flow in the TTL data link that seems to coincide with energizing the interface—see Figure 16. The signal is only present on channel associated with the TTL data link and was recorded by the monitoring equipment on several occasions when the interface was activated. This is probably a normal situation associated with the testing process and not associated with the communications problems being experienced at other times.

Figure 16 – TTL data link event at time of interface activation.

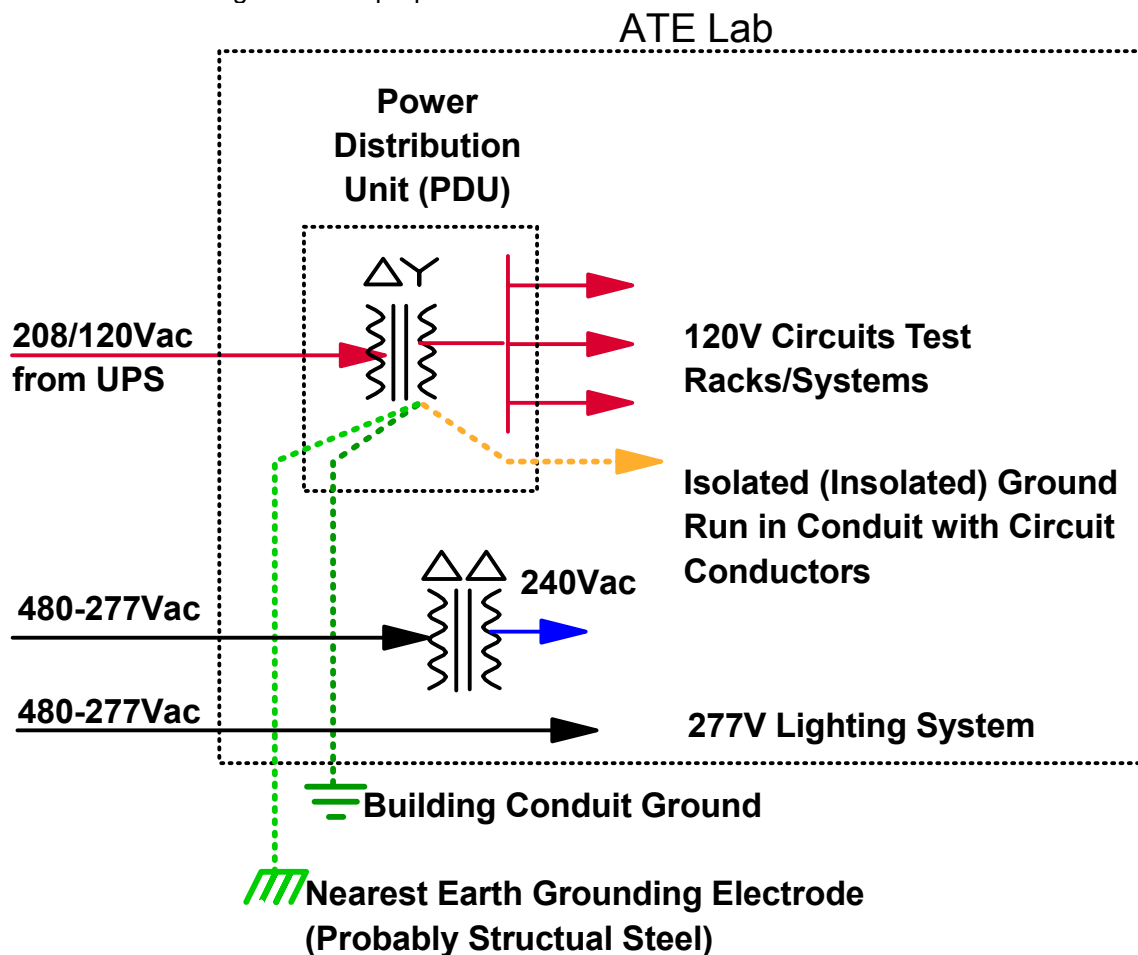
Figure 17 – Proposed electrical distribution for ATE Lab with PDU.

The objective of any mitigation activity should be to establish a separately derived electrical supply serving the electronic test systems in the ATE Lab. Further it will be necessary to insulate the electrical distribution connected to the test bays from the building conduit system. This program can best be accomplished through the installation of an isolating—delta-to-wye transformer—Power Distribution Unit (PDU) adjacent to the D40 panelboard. The electrical distribution on the secondary of the PDU should be via liquid tight flexible conduit—care should be taken to ensure that the PDU distribution does not come in contact with the building conduit system or other extraneous grounds.

The PDU equipped with the delta-wye transformer provides for a neutral-ground bond on the secondary as well as a capacitive filter output to attenuate transients and load interaction within the ATE Lab area.

Figure 17 below is a diagram of the proposed electrical distribution for the ATE Lab.
