Load Study XYZ Company 1234 N. Peach St., Fruit City, CA 98331

Monitoring Period: 05/14/2008 @ 12:15:00 to 06/17/2008 @ 10:00:00

Introduction

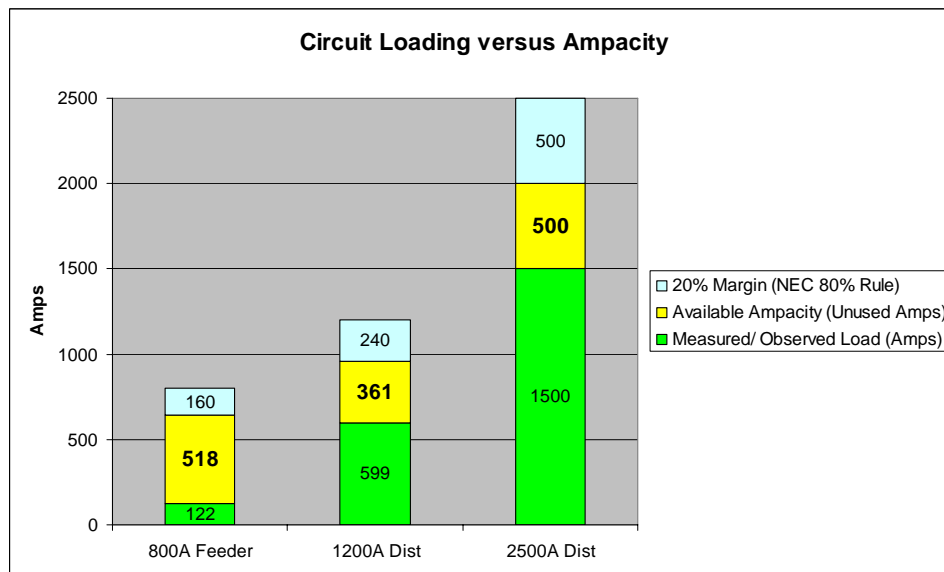
Chart 1 – Summary of load study. (Note: Yellow indicates available load amps to support additional equipment.)

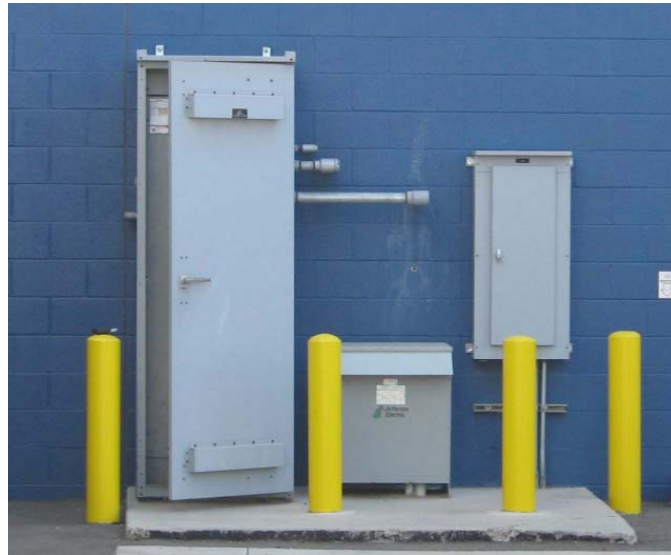
The Dranetz-BMI PP4300 monitor was installed in the base of DB1 (Photo 1, below) for a 30-day period. The following section documents the results of the monitoring for this location.

The results of the monitoring indicate that CB1 is approximately 20% loaded and that 518Amps of additional load could be placed on the circuit.

Photo 1 – Panelboard DB1 3P4W 480/277Vac 800A.

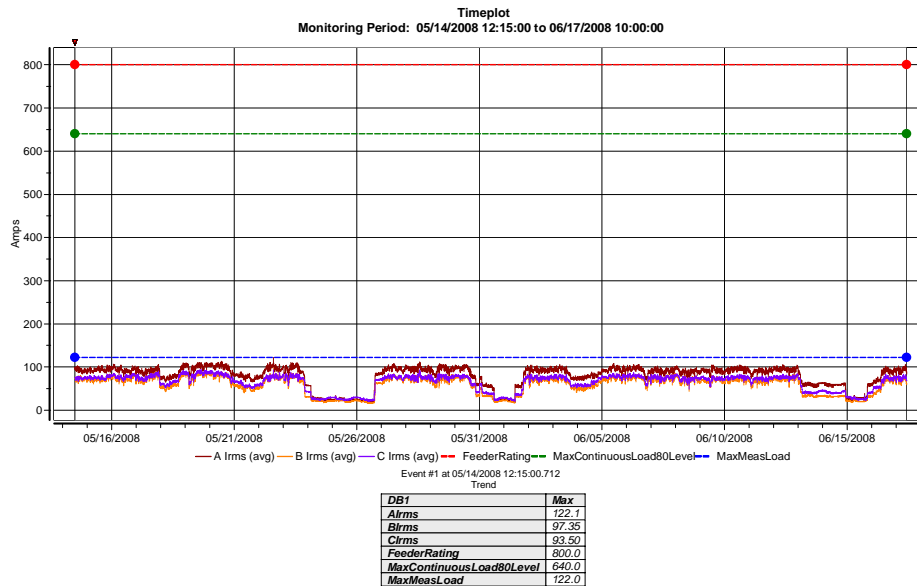
Figure 1 is the current time plot for CB1 along with limit lines graphically illustrating the existing circuit loading and available capacity.

Figure 1 – Current time plot for DB1 showing limit lines for circuit rating and maximum continuous load (80% rule).

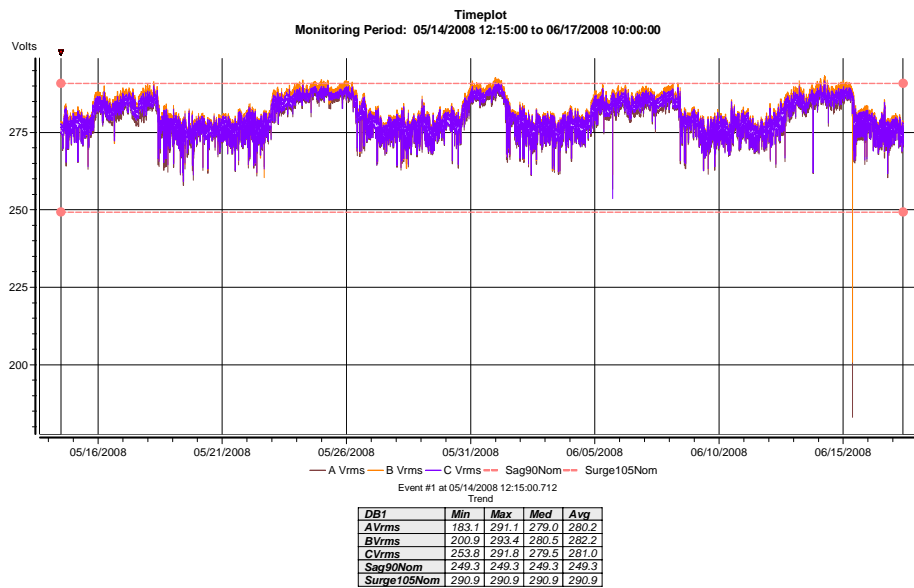
Figure 2 (below) shows the voltage time plots for the three phases during the monitoring period. There was one significant voltage event on 6/15/08 when phase-to-neutral voltage levels dropped to 183V on phase A. With out additional monitoring waveform data it is not possible to accurately evaluate the source of the voltage sag, but in all likelihood it was a utility sources fault clearing operation. Voltage levels appear to be within expected ranges.

Figure 2 – Voltage time plot for DB-1.

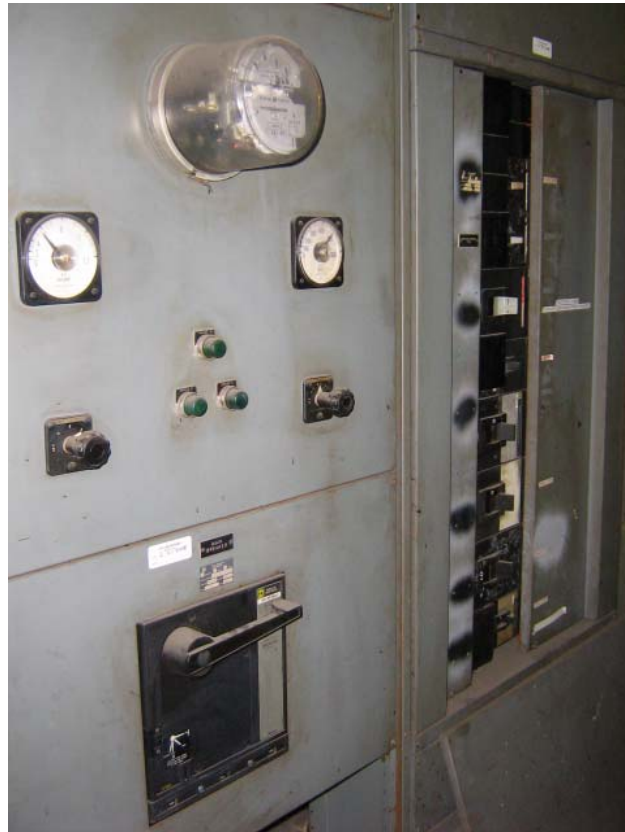
Photo 2 – SWBD NO. 3 is a 480V 3P3W 1200Amp supply.

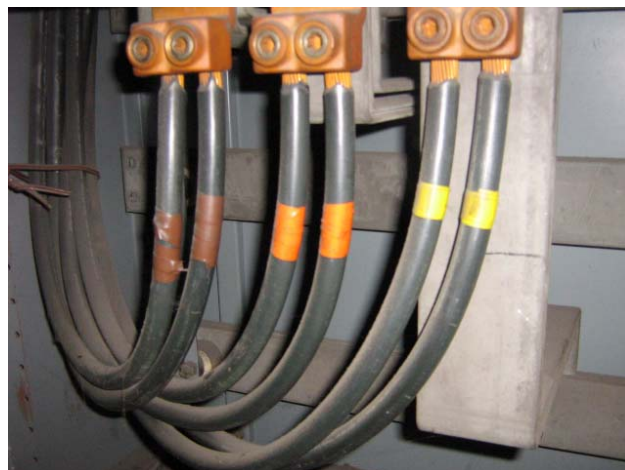
The metering equipment was installed in the bottom of the SWBD No. 3 (Photo 3 below) just below the cables shown in the photo.

The cables, in Photo 2 appear to be a tap on the load side of the 1200A breaker. Their termination point is not known at this time. There may be some NEC code issues with this configuration as there is the question of if the tap (conductors) is rated for the 1200A application. Also there are restrictions on the length of the tap conductors.

Photo 3 – SWBD 3 showing tap off main breaker.

The configuration of SWBD No. 3 (1200A) and SWBD No. 3A (2500A) needs to be documented and then reviewed by an engineer as there may be some code issues with the present configuration.

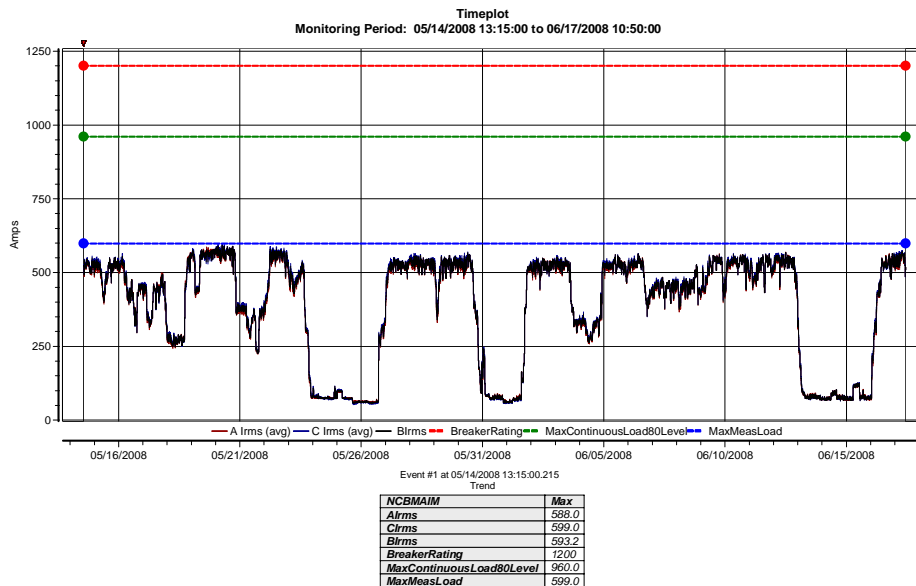
The results of the monitoring indicate that SWBD No. 3 is approximately 62% loaded and that 361Amps of additional load could be placed on the circuit. An additional of 90Amps of capacity could be obtained by improving the power factor (PF) by 0.15.

Figure 3 is the current time plot for CB1 along with limit lines graphically illustrating the existing circuit loading and available capacity.

Figure 3 – Current time plot showing limit lines for circuit rating and maximum continuous load (80% rule) for SWBD 3.

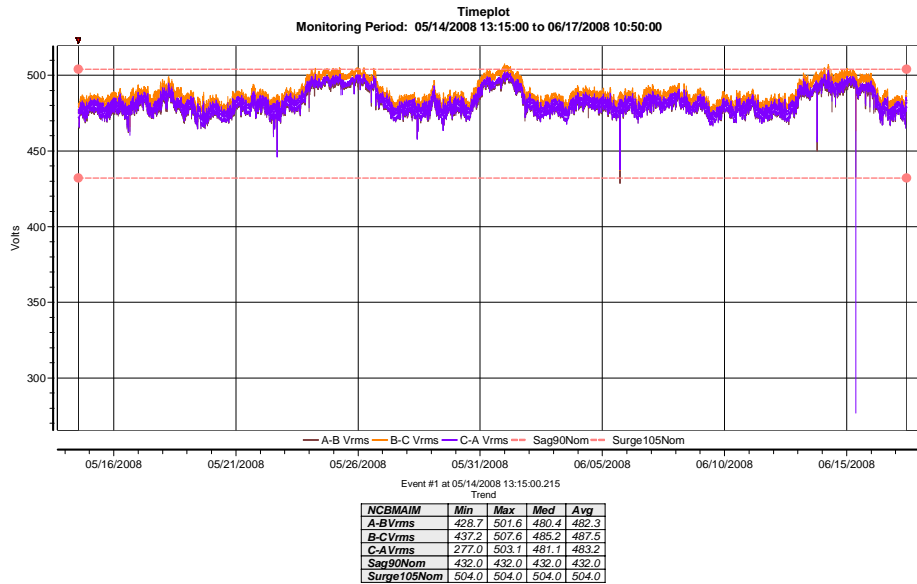
Figure 4 (below) shows the voltage time plots for the three phases during the monitoring period. There was one significant voltage event on 6/15/08 when phase-to-phase voltage levels dropped to 277V on phase connection CA. With out additional monitoring waveform data it is not possible to accurately evaluate the source of the voltage sag, but in all likelihood it was a utility sources fault clearing operation. Voltage levels appear to be within expected ranges.

Figure 4 – Voltage time plot showing +5% and -10% limit lines for SWBD 3.

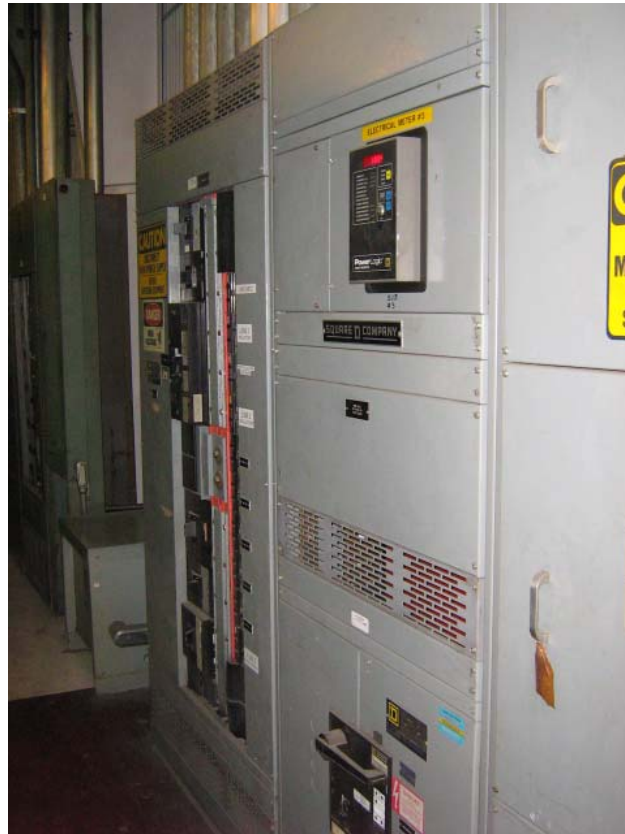
No power monitor was connected to this switchgear, but the phase amp readings were observed from the installed PowerLogic (Electrical Meter #3) panel meter with the plant operating on Tuesday, Jun 17th at approximately 11AM.

Actual observations were approximately 1450Amps/Phase. The following table summarized the likely loading conditions existing for this switchboard.

Photo 4 – SWBD No. 3A.
