Consulting Report Main Circuit Breaker Testing 1 Shore Circle, Sparkle Bay, CA For Altair

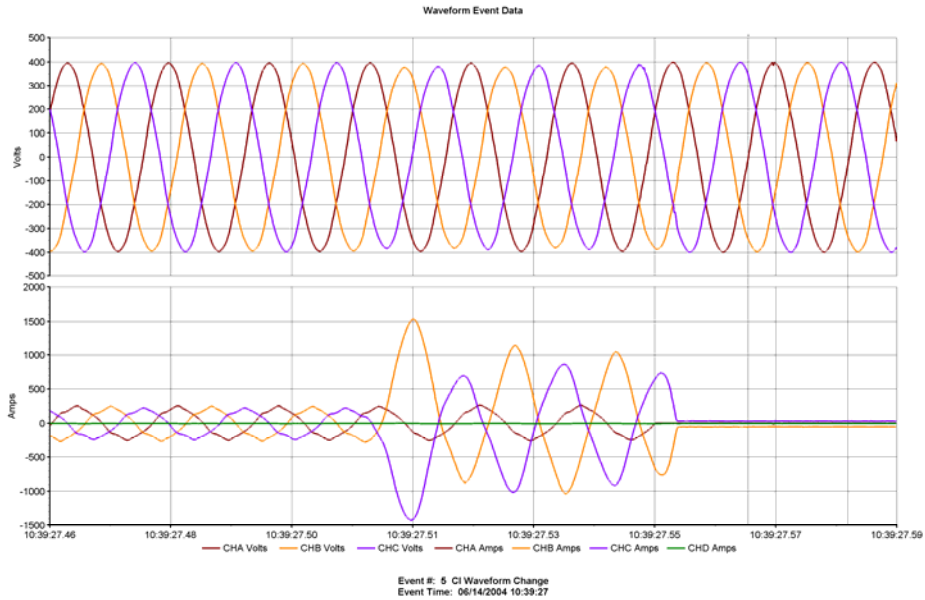
Figure 1 is the voltage and current waveform associated with the initial test—amperage scale in Figure 1 represents peak current levels and not RMS. The current waveforms document the breaker operation

approximately 50 milli-seconds after turn-on of the chiller. Figure 2 is the time plot data showing a maximum RMS current of 860A on phase B.

Phase A in Figure 2 does not appear to have any in-rush (start-up) current and may indicate a problem with this chiller.

Figure 1 – Voltage and current waveforms from initial chiller turn-on test. Breaker opens approximately 50ms after turn-on of chiller.

1. The chiller cycled during the initial test should be tested and inspected. Current waveforms indicate that there may be a single-phasing condition—refer to Figure 1—as no inrush current was recorded on phase A. The chiller cycled during the second test appears to be normal—refer to Figure 3.
2. Current levels recorded during the two chiller tests should not be sufficient to trip the main circuit breaker. The existing breaker should be tested (calibrated) and replaced if it can not be adjusted (repaired) in the field.
3. It appears that the Pick-up Amperes setting for the ground fault section of the breaker was adjusted sometime after testing completed on 7/23/2002. Ground fault settings should be verified and the circuit breaker readjusted to the correct setting.
4. A battery powered emergency light should be installed in the main power room.

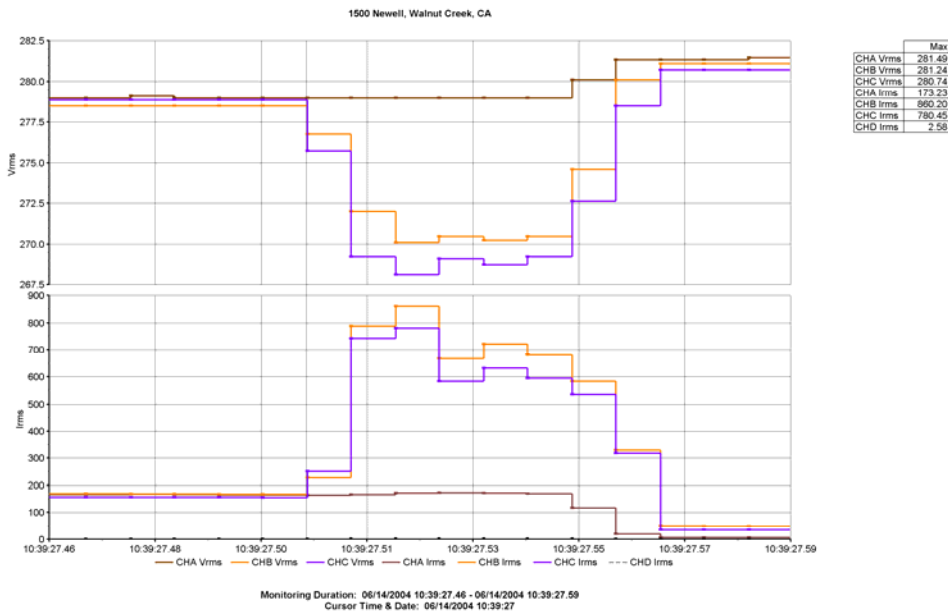
Figure 2 – Voltage and current RMS time plot data from initial chiller turn-on test. Maximum current was approximately 860A RMS on phase B.

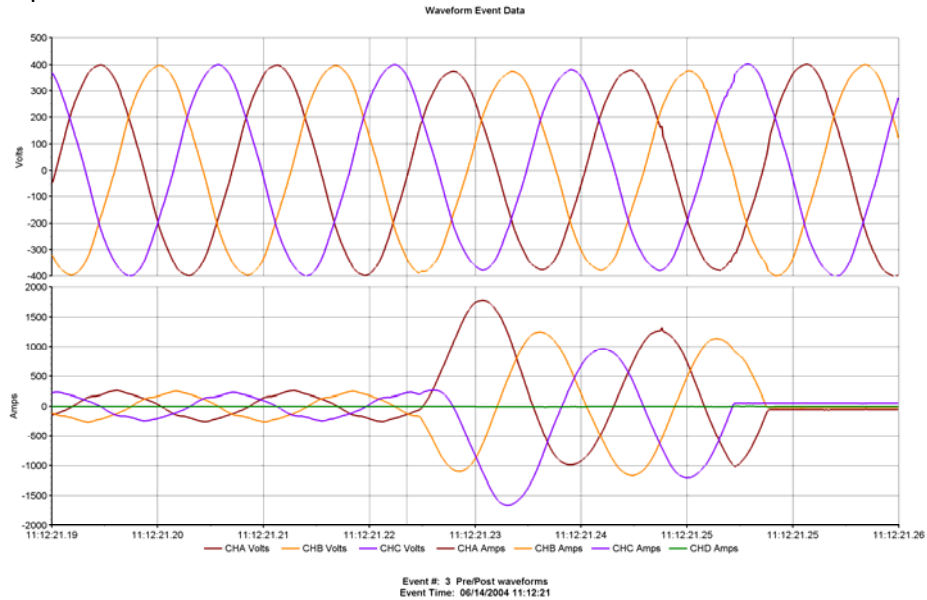
Figures 3 and 4 show the waveform and time plot data from the second chiller test. Note in this case there is consistent inrush on all 3-phases. The maximum current for the second test was approximately 936A RMS on phase C.

Figure 3 - Voltage and current waveforms from second chiller turn-on test. Breaker opens approximately 32ms after turn-on of chiller.

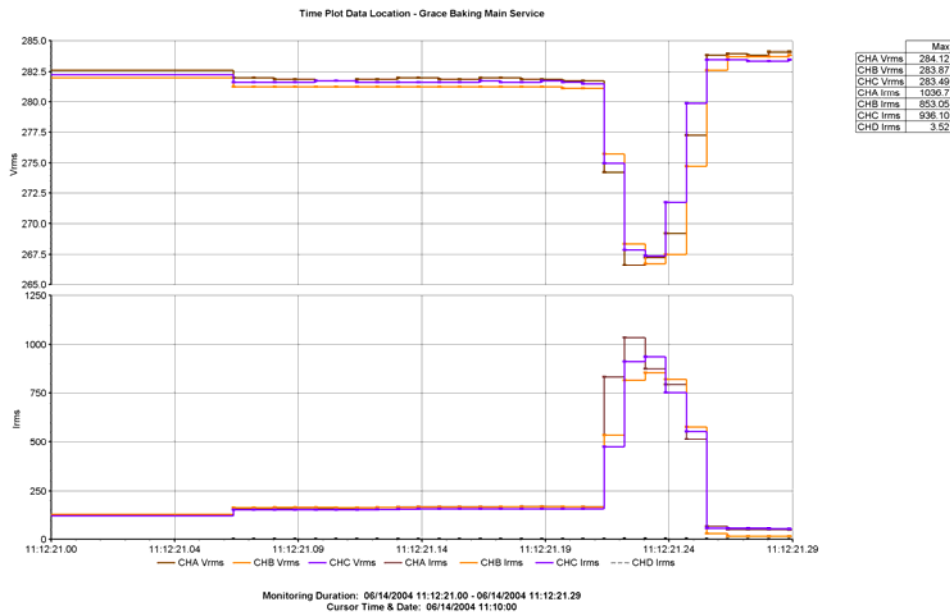
Figure 4 - Voltage and current RMS time plot data from second chiller turn-on test. Maximum current was approximately 936A RMS on phase C.

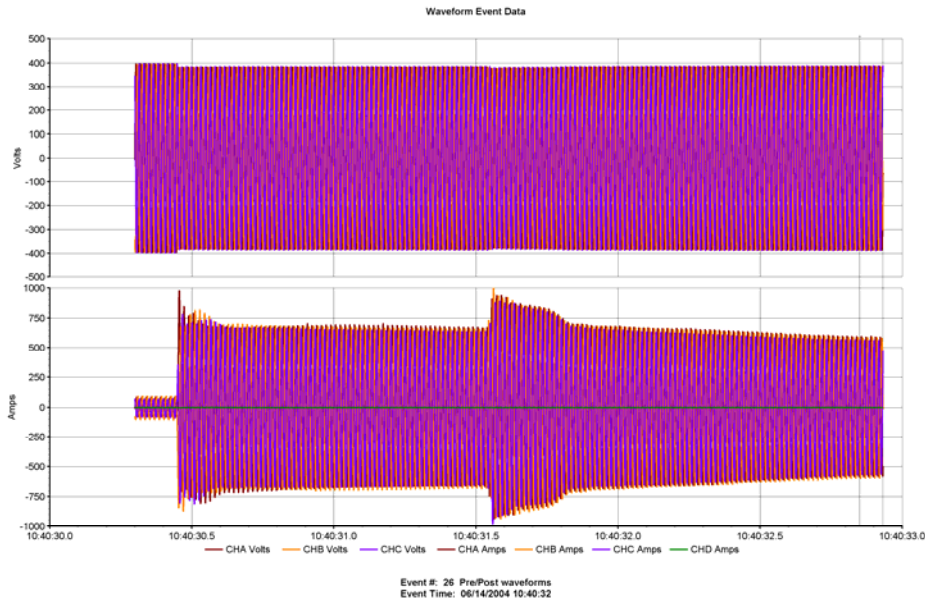
Figure 5 shows the voltage and current waveform envelop as the main breaker was reset after the initial chiller test. There is a second current inrush that occurs approximately 1-second after the reset of the breaker. This most likely some of the building's equipment with a time delay after restoral of power.

Figure 5 – Waveform envelop showing reset of circuit breaker followed by additional loads being cycled on approximately 1-second after breaker is reset. (Note: Date is from initial chiller test activity.)

The nominal load on the building during the tests, with the chillers off, was approximately 170A per phase which seems quite low. The amperage recorded at the end of the initial test, Figures 5 and 6 show a much larger current in the 400 to 500 ampere range. There is only 2-seconds of data and it may simply be inrush associated with equipment in the building restarting.

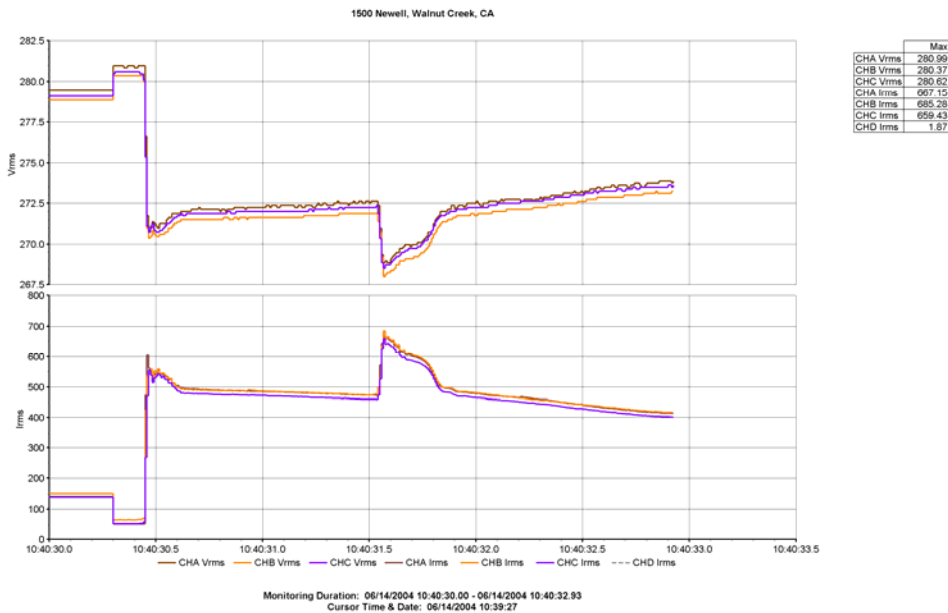
Figure 6 - Voltage and current RMS time plot from Figure 6. Maximum current was approximately 685A RMS on phase B. Breaker did NOT trip under these conditions—chiller was not cycled during this period.

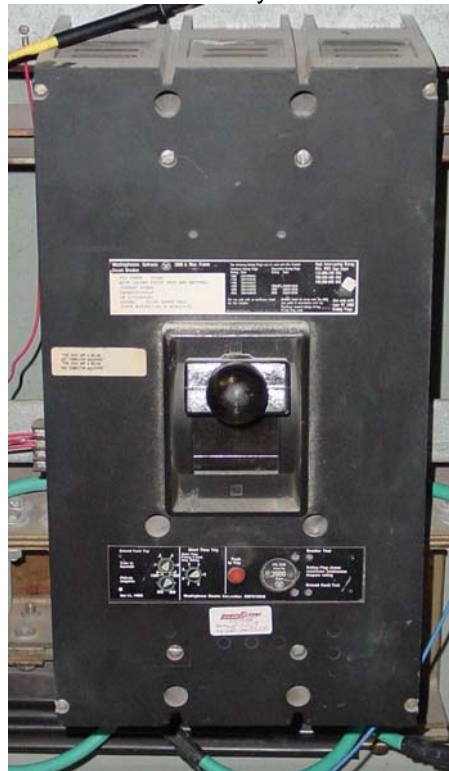
Photo 1 is a picture of the main 2000A breaker currently installed at 1 Shore Circle, Sparkle Bay, CA.

Photo 1- Main 2000A curcuit breaker.

[Note: The 2000A breaker was replaced 2-days later and there have been no other reported problems.]

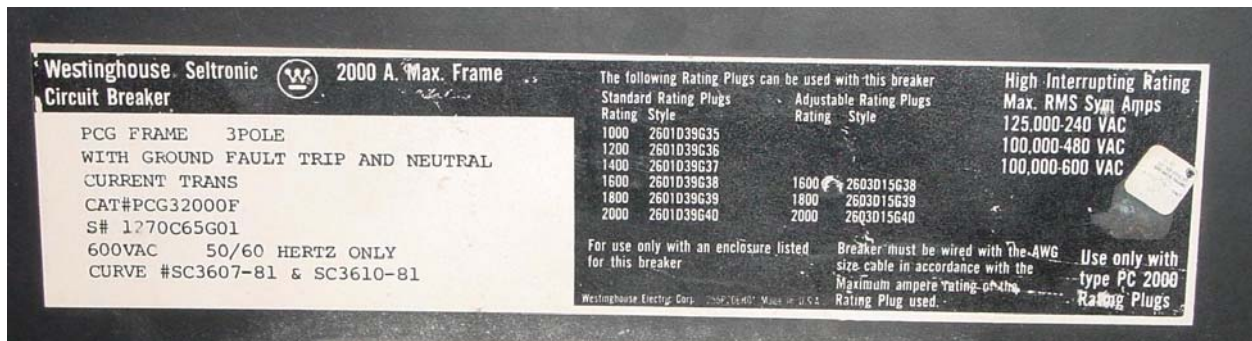
Photo 2 shows the name plate for the main 2000A breaker in Photo 1.

Photo 2 - Main 2000A breaker name plate.

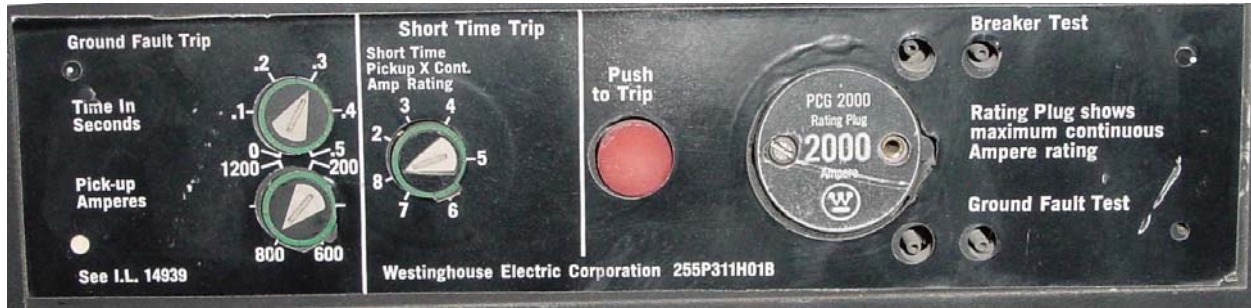
Photo 3 shows the adjustment controls for the main 2000A breaker. The **Ground Fault Trip** is set for a 0.3-second (300ms, 18-cycle) delay with a **Pick-up Amperes** setting of 800A. The cover panel sticker in Photo 4 shows that the **Pick-up Amperes** setting was set to 400A on 7/23/2002.

The Short Time Trip level, Photo 3, is set at 8. To obtain the actual ampere rating the continuous Amp Rating (probably 80% of the 2000A) is multiplied by the setting. The setting of 8 most likely corresponds to an ampere setting of 12,800A. (Note: Detailed specifications of the breaker were not available for this report.)

Photo 3 - Main 2000A breaker ground fault and short time trip settings.

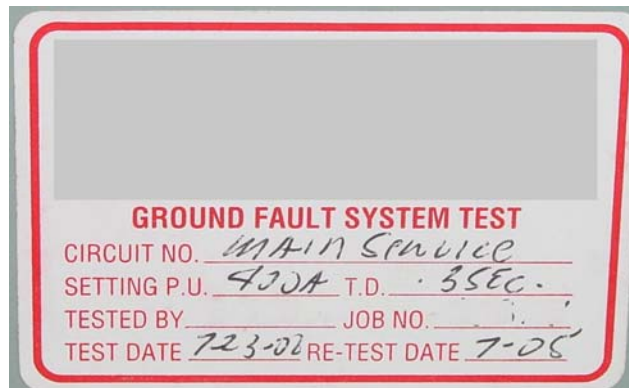
Photo 4 - Panel cover sticker for main 2000A breaker showing settings and date of last test/calibration.
