## Problem Investigation Report Motor Drive Tripping Problem

The client's office building has experienced a number of motor drive problems. Specifically the drives are reportedly tripping-off on an over-temperature (heating) alarm associated with the input rectifier section of the drives power supply. The problem has been occurring most frequently in the early morning hours shortly after the HVAC system are brought on-line in preparation for building occupancy.

PowerCET Corporation was retained to determine if the quality of the electric supply could be causing the operational problems with the motor drives.

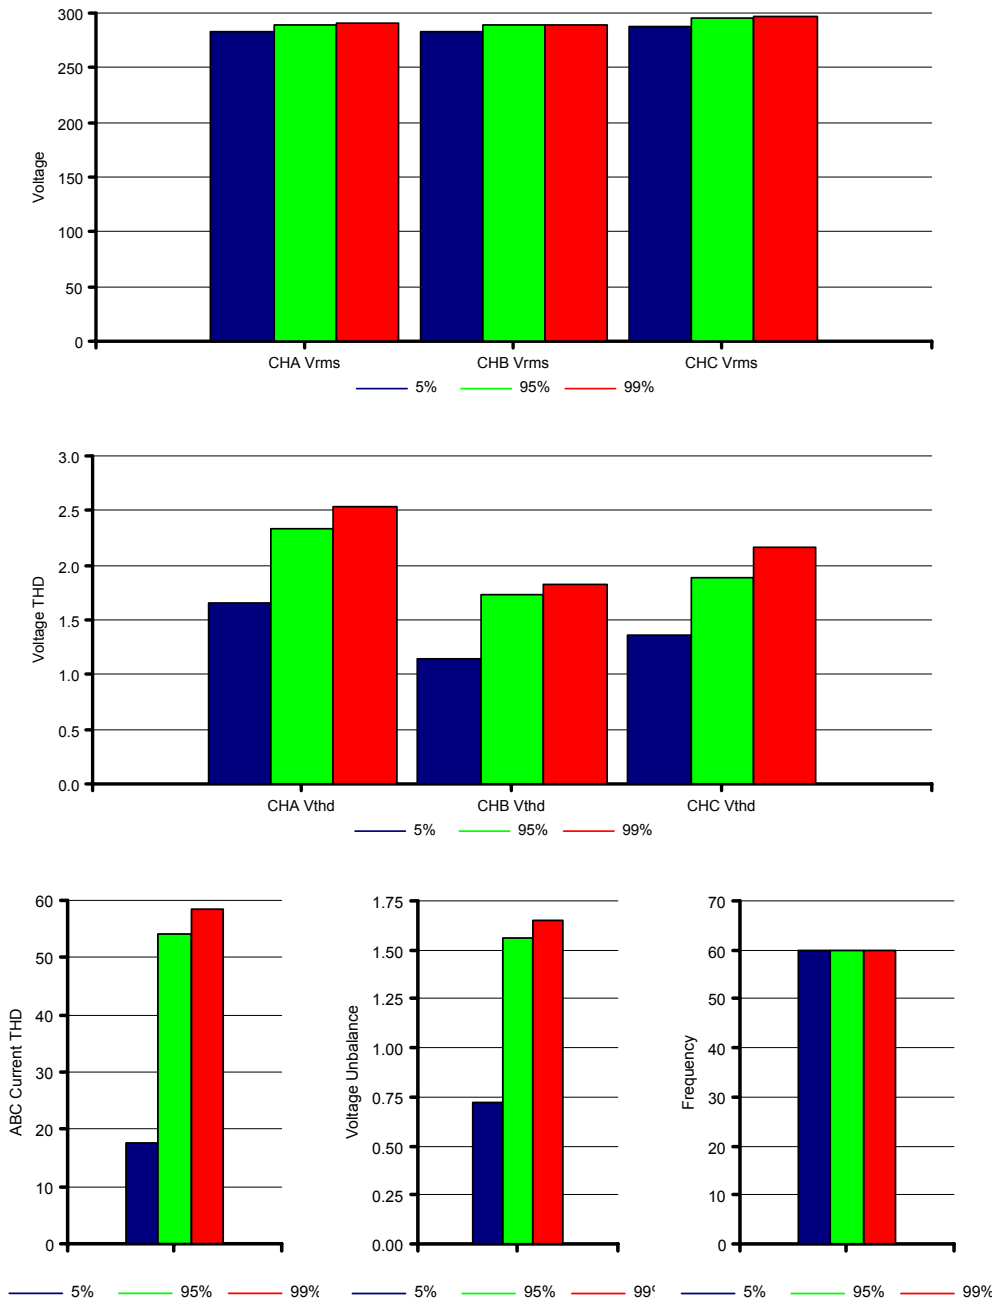
The following quality of supply graphs, Figure 1, summarize the general quality of the electrical supply. Both current and voltage harmonic distortion levels are within acceptable limits. The current harmonic distortion (I<sub>thd</sub>) is highest under the minimum load condition—when the building is not occupied. Voltage unbalance again is within an acceptable range and as with the current distortion is highest during non-operating hours and is dominantly utility related—the present building loads do not significantly impact the voltage unbalance.

**Figure 1 - Quality of supply graphs for line-neutral RMS voltage.** [Note: *Quality of Supply Summary Graphs*—Interpretation of the Quality of Supply Summary Graphs (Figure 1) is sometimes confusing. It is best to think of the result as: for N% of the time the values are less than or equal to the N% value, for the remainder of the time it is greater (where N is 5, 95 or 99). Graphs are provided for Vrms, Vthd, ABC Current THD, Voltage Unbalance and Frequency.]

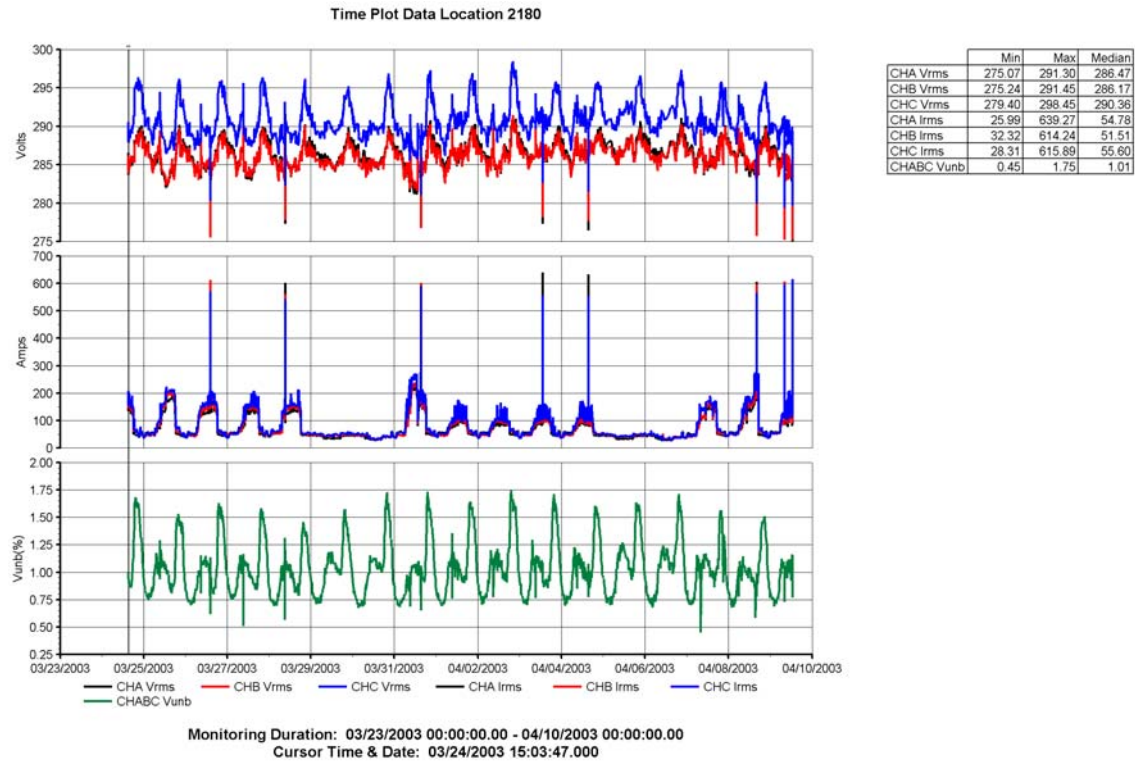
Figure 2 below is a time plot of the monitoring data from the main electrical service which shows the RMS voltage, RMS current and the phase voltage unbalance (phase-neutral, 277V). The eight voltage sags to approximately 275V are the result equipment cycling in the building—probably the compressor located in the rooftop equipment room.

Two weekends are shown in Figure 2 data and demonstrates that the phase voltage unbalance is approximately the same on weekends when the building loads are off. In addition the most severe unbalance condition occurs between 6PM and midnight. The nature of the utility grid in the immediate area may account for voltage unbalance timing, as there is a substantial residential area immediately adjacent to the business park.

**Figure 2 - RMS voltage (phase-neutral, 277V), RMS current and voltage unbalance time plot at main electrical service.**

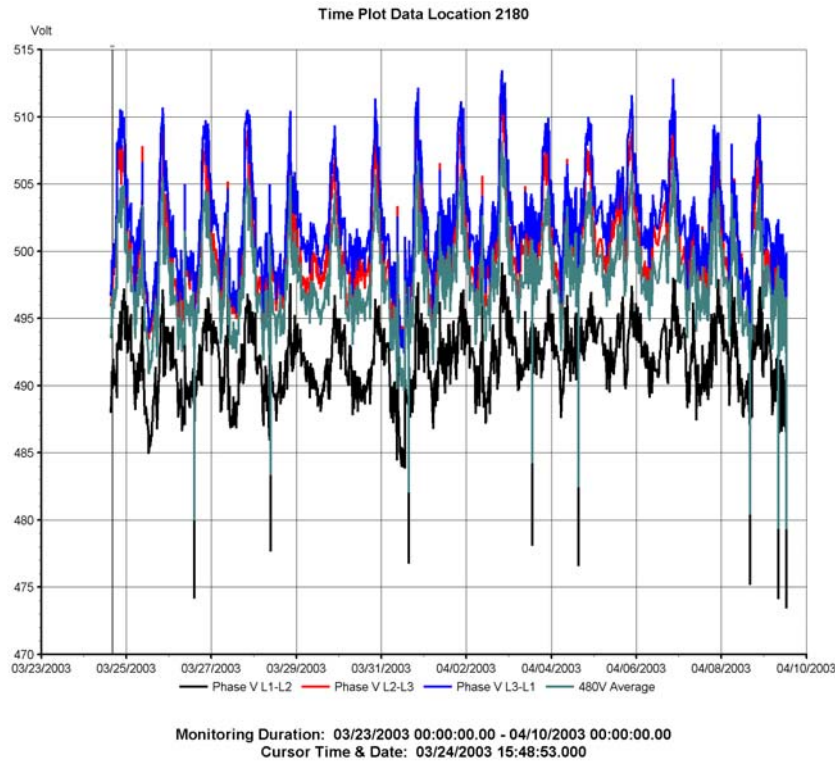
Figure 3 shows the RMS voltage time plots for the phase-to-phase (480V) supply at the main electrical service. The average voltage level for the 480V supply is approximately 497 Volts. The median voltage levels for two of the phase combinations are approximately 500 Volts, which is high enough to cause potential problems for the power supply of the drives.

The nominal voltage level supplied from the utility has probably increased as the loads in the nearby office complexes have decreased. The client's building is an example as its maximum-recorded load during the monitoring period was approximately 200 Amps per phase—the facility has a 1000 Amp utility service.

**Figure 3 - RMS voltage time plot (phase-to-phase, 480V) at main electrical service.**

- 1. RECOMMENDATION:** There is a high probability that tapping the transformer down 2.5% to 5% would resolve the problems being experienced with the motor drives. Since the building is virtually shutdown during weekends it would be an ideal time to accomplish a transformer tap change. The local utility representative should be contacted to arrange for the change. Figure 4 shows the time plot of the average value for the 480V supply and corresponding time plots for a 2.5% and 5% voltage reduction. The present monitoring data indicates that a 5% reduction would be possible, but give the time-of-year and possibility that the summer air-conditioning season could provide additional voltage drop a 2.5% reduction is a more conservative approach at this time with a reasonable probability of resolving the operational problems with the motor drives.

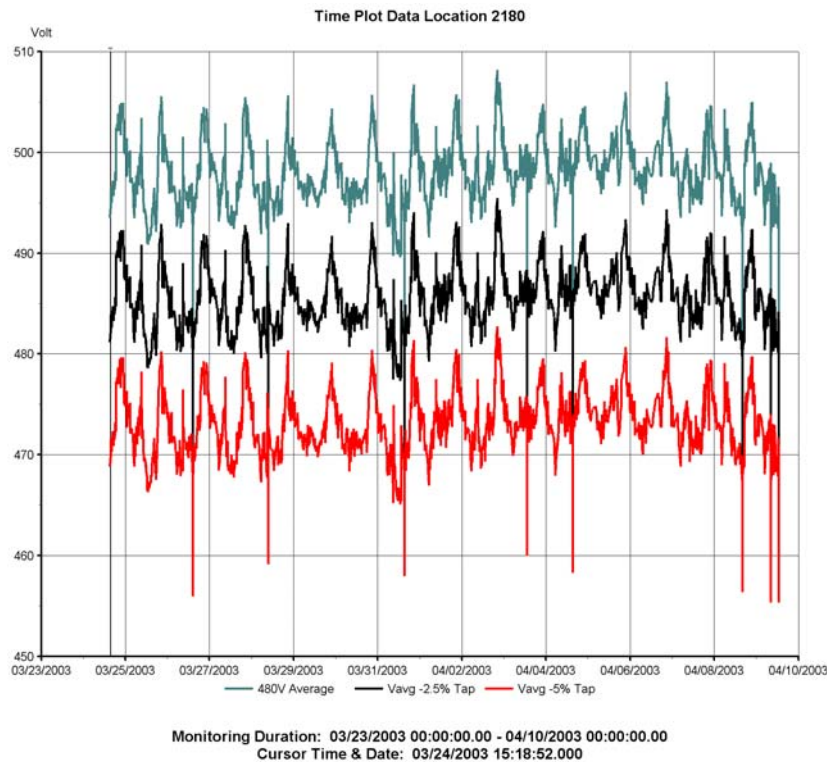
**Figure 4 - 480V electric utility supply tap comparison—black -2.5% and red -5%.**

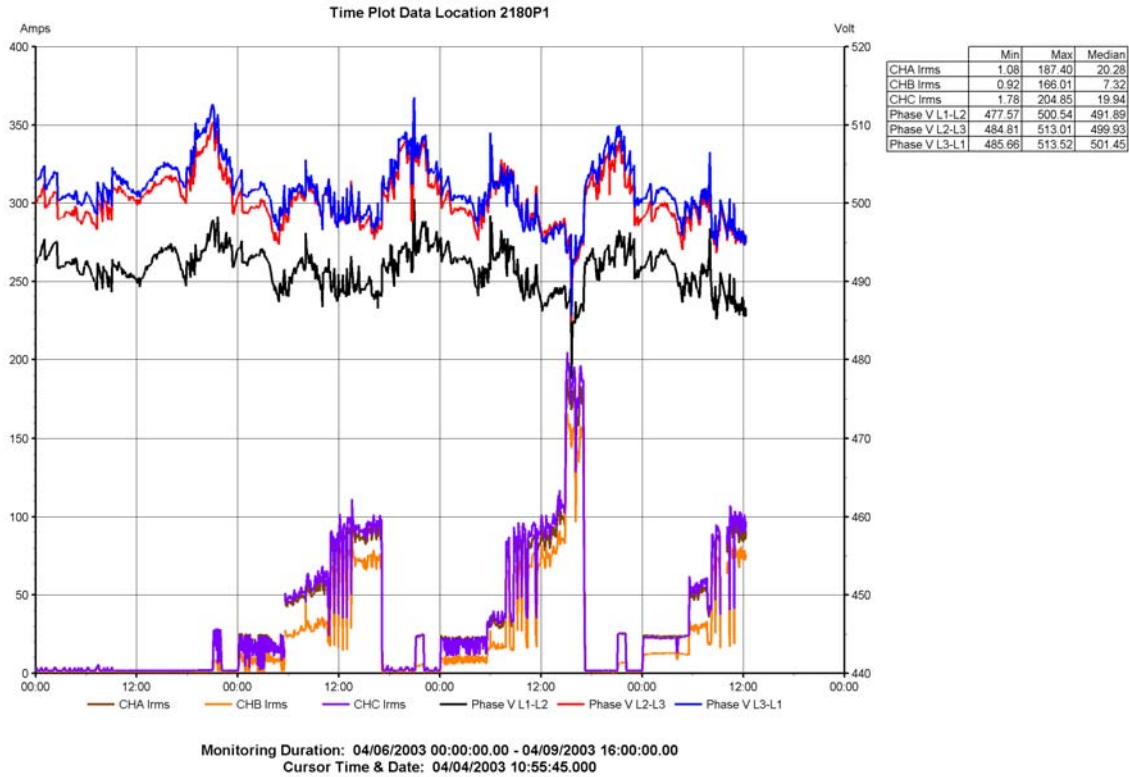
Figure 5 shows the 4-day RMS current and voltage time plot comparison at the panelboard in the rooftop equipment room serving the motor drives. As was the case with the voltage levels at the electrical service the nominal 480V levels are excessive and should be reduced which will likely resolve the performance issue with the motor drives.

**Figure 5 - RMS voltage and current time comparison.**

Other than the high line conditions there are no power anomalies that would account for the drive problems. Re-tapping the utility supply transformer—recommendation #1—down by 2.5% or 5% will in all likelihood resolve the drive performance problems.

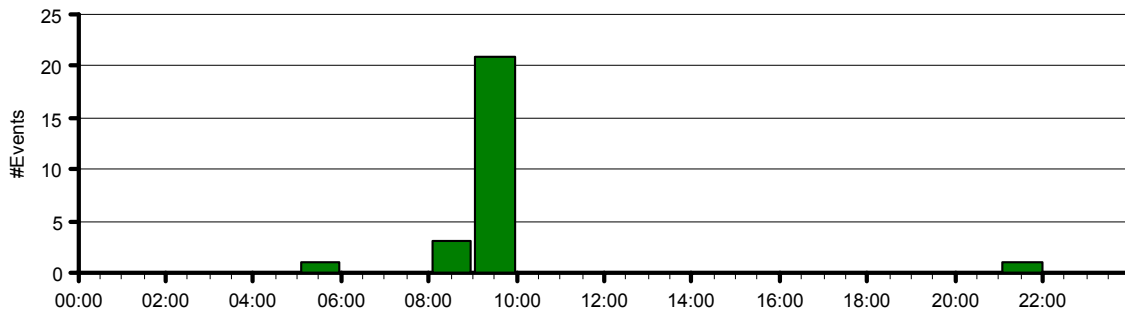
During the monitoring period a series of voltage transients were recorded—approximately 25 in total. The bulk of the transients occur between 9AM and 10AM each day and are most likely associated with utility power factor capacitor switching. Figure 6 shows the frequency of occurrence of the transients and Figure 7 is a representative example of the transient event recorded by the monitoring equipment at the main electrical service.

**Figure 6 - Voltage transient occurrence by quantity and time of day.**

- RECOMMENDATION: At this time the transients do not appear to be impacting the buildings operation. In the future should specific loads react to this type of event then mitigation equipment should be employed on a case-by-case basis. Generally an on-line (double conversion) UPS will provide the necessary conditioning to mitigate this type of problem on small computer and electronic loads. No action required at this time.**

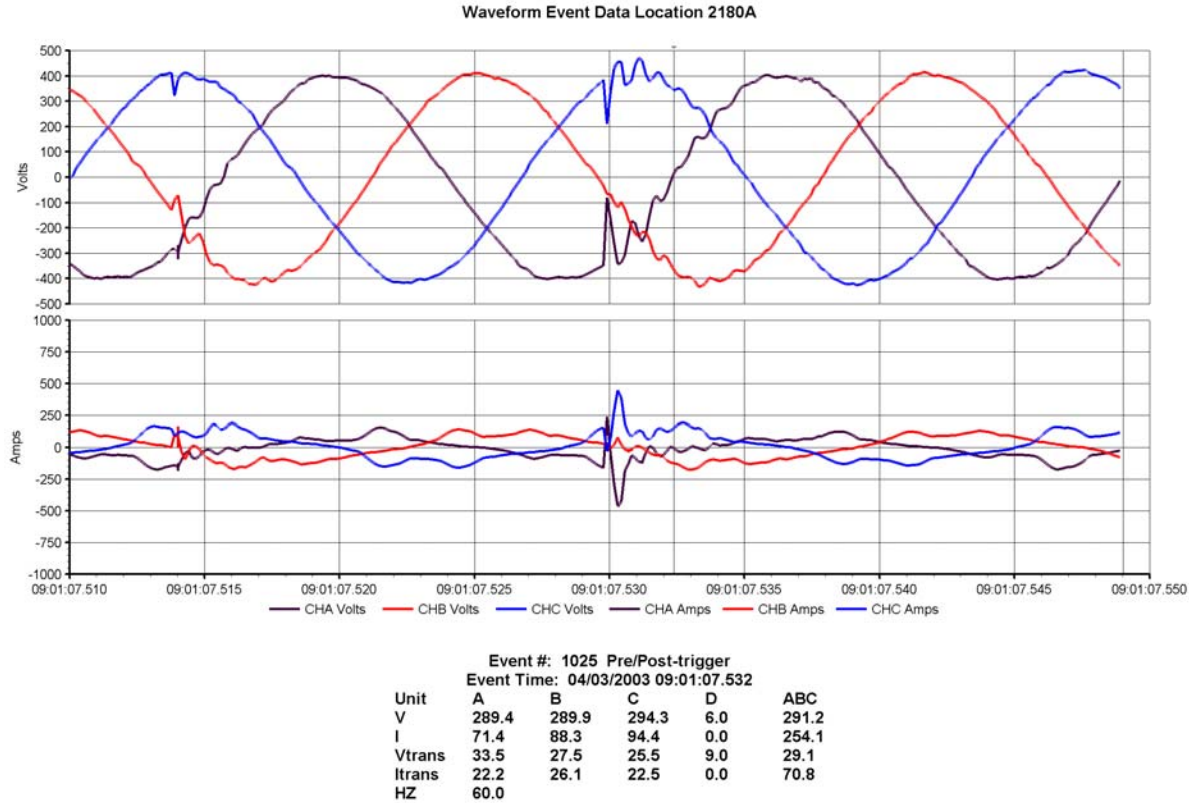
**Figure 7 - Representative waveform event of utility power factor switching event.**
