**Consulting Report
 Noisy Transformer Problem Investigation
 OPM Office Building
 1000 Shellfish Drive, Somewhere Valley, CA**

Introduction

A 225KVA distribution transformer located on the 5th floor of 1000 Shellfish Drive is very noisy resulting in tenant complaints. PowerCET Corporation was requested to inspect and measure the electrical load on the associated transformer in an attempt to determine the cause of the excessive noise.

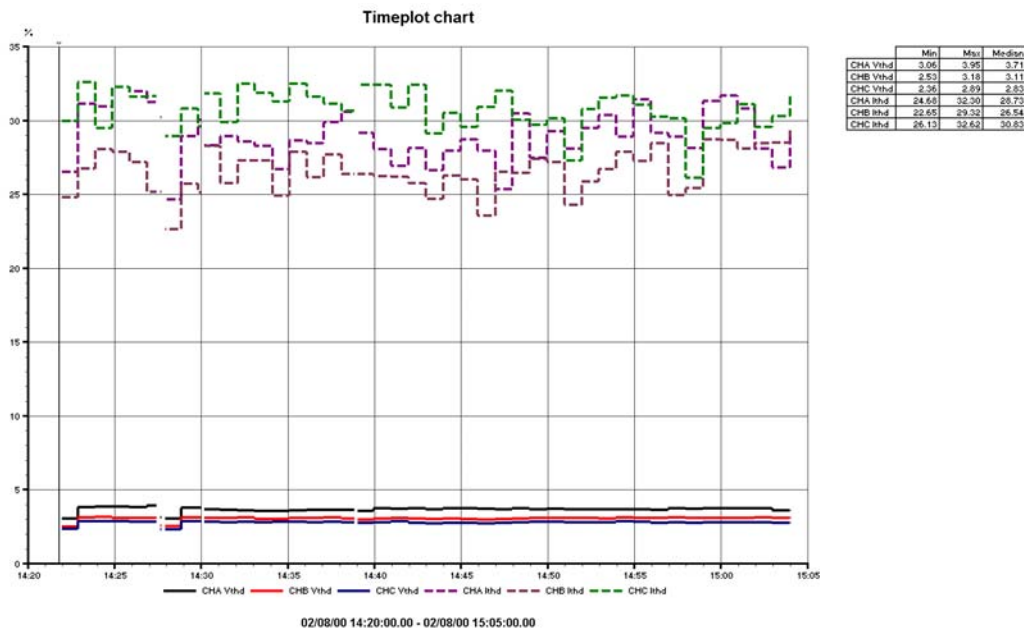
Figure 1 - Voltage & Current Harmonic Time Plots.

1. The transformer is very noisy but not over heating. The quality of supply graphs on the following page indicates normal voltage levels with harmonic distortion (THD) levels at acceptable levels.
2. The voltage harmonics range from 3% to 4% with Phase A the highest—which is consistent with the phase loading as phase A has more connected load.
3. The current harmonics range from 25% to 35% THD, which is not excessive and should not normally pose a problem. Figure 1 below shows the time plot for both voltage (VTHD) and current (ITHD) for the brief monitoring period.

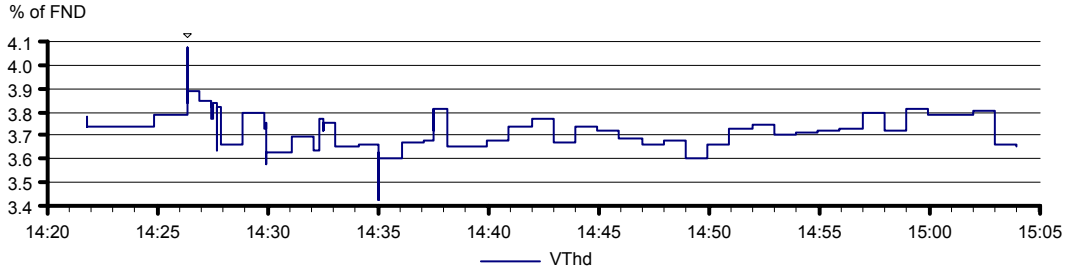
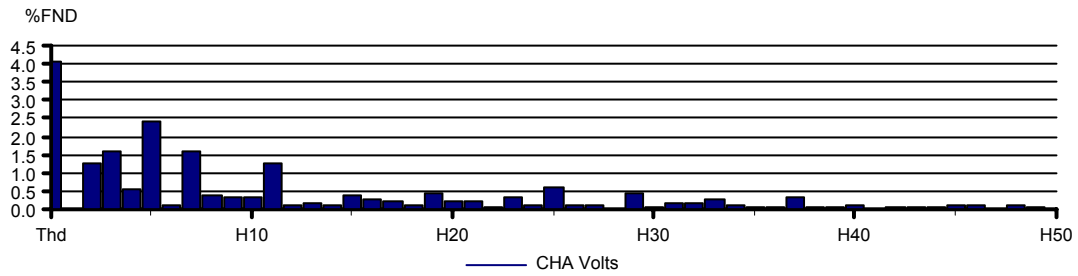
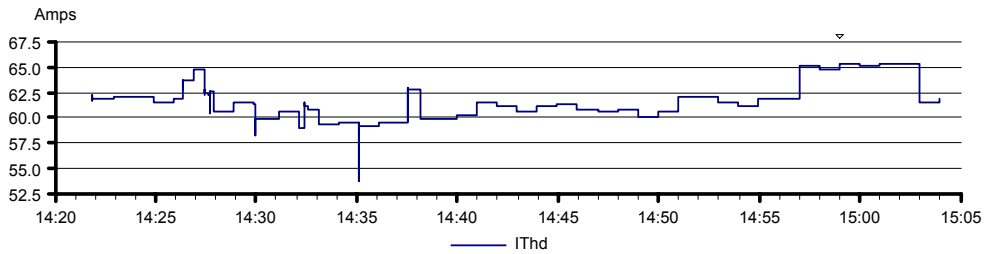
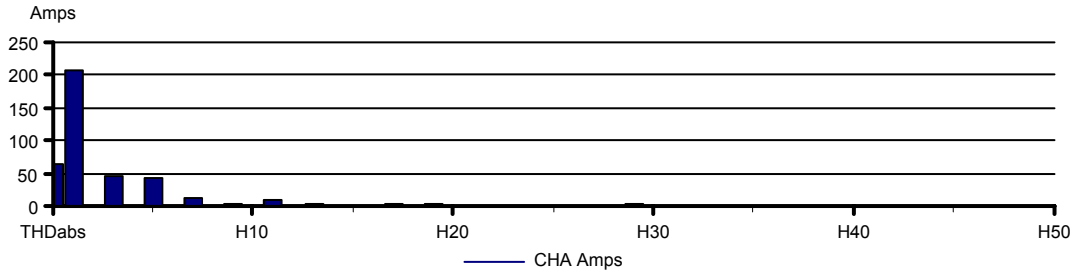
PHASE A - HARMONIC TIME PLOTS FROM 02/08/00 14:21:46 TO 02/08/00 15:03:57

Total RMS: 120.62 Volts
 Fundamental RMS: 120.50 Volts
 Total Harmonic Distortion (H02-H50): 4.08 %FND
 Even contribution(H02-H50): 1.56 %FND
 Odd contribution(H03-H49): 3.76 %FND

Total RMS: 217.47 Amps
 Fundamental RMS: 207.38 Amps
 Total Harmonic Distortion (H02-H50): 65.32 Amps
 Even contribution(H02-H50): 1.95 Amps
 Odd contribution(H03-H49): 65.29 Amps

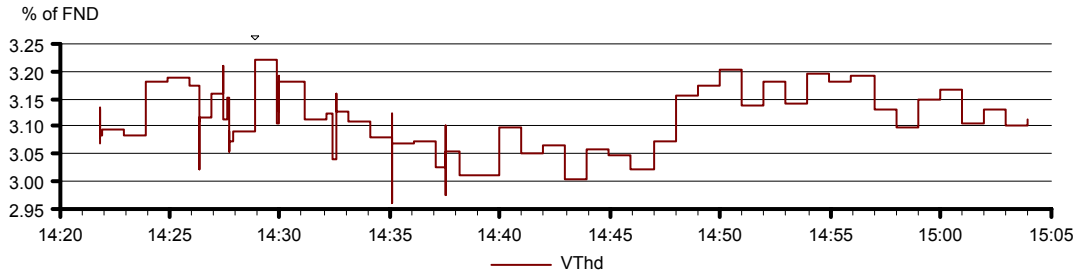
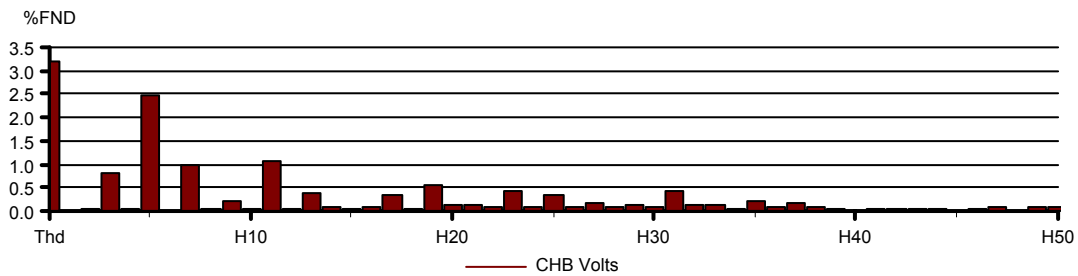
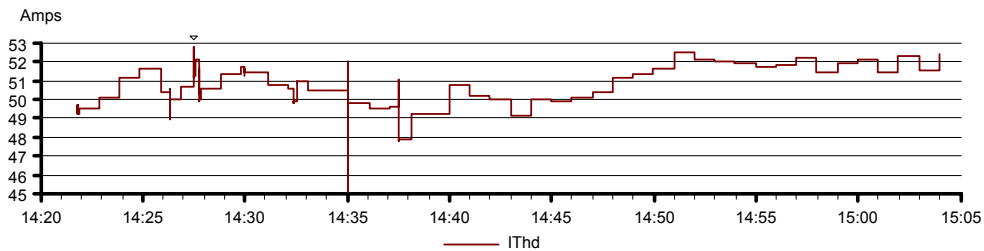
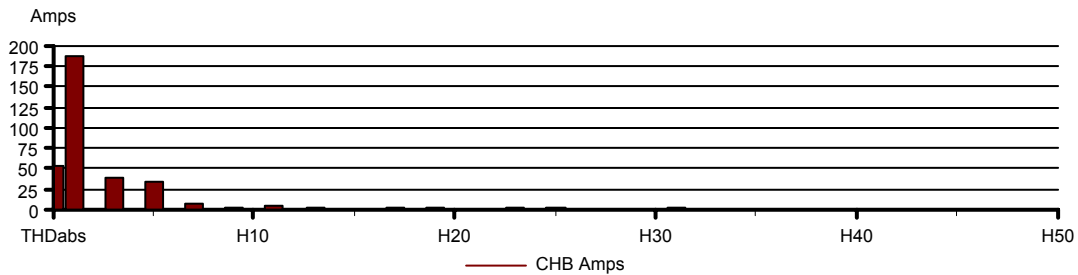
PHASE B - HARMONIC TIME PLOTS FROM 02/08/00 14:21:46 TO 02/08/00 15:03:57

Total RMS: 121.34 Volts
 Fundamental RMS: 121.26 Volts
 Total Harmonic Distortion (H02-H50): 3.22 %FND
 Even contribution(H02-H50): 0.34 %FND
 Odd contribution(H03-H49): 3.20 %FND

Total RMS: 195.00 Amps
 Fundamental RMS: 187.70 Amps
 Total Harmonic Distortion (H02-H50): 52.82 Amps
 Even contribution(H02-H50): 1.94 Amps
 Odd contribution(H03-H49): 52.78 Amps

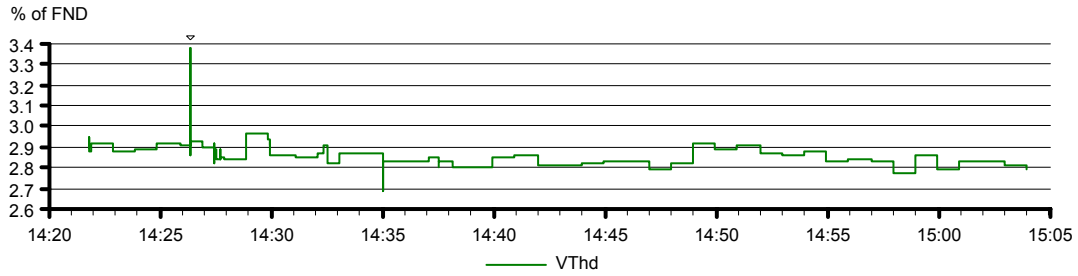
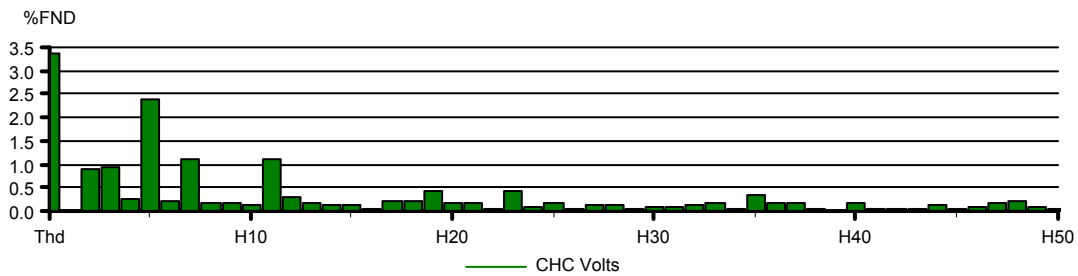
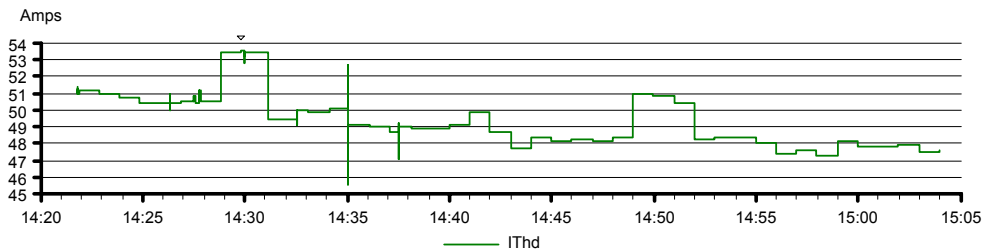
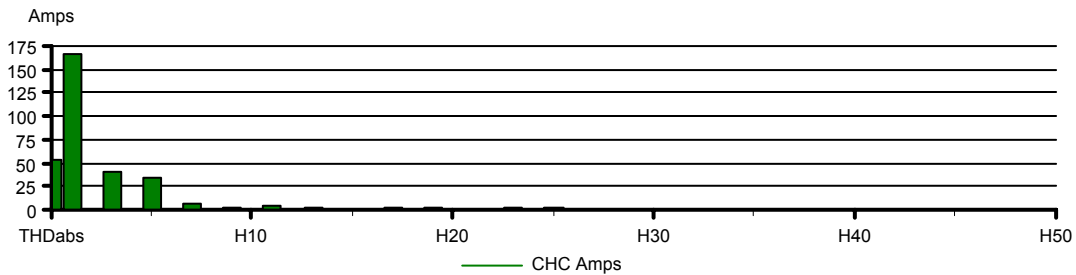
PHASE C - HARMONIC TIME PLOTS FROM 02/08/00 14:21:46 TO 02/08/00 15:03:57

Total RMS: 121.18 Volts
 Fundamental RMS: 121.11 Volts
 Total Harmonic Distortion (H02-H50): 3.38 %FND
 Even contribution(H02-H50): 1.17 %FND
 Odd contribution(H03-H49): 3.17 %FND

Total RMS: 173.98 Amps
 Fundamental RMS: 165.48 Amps
 Total Harmonic Distortion (H02-H50): 53.60 Amps
 Even contribution(H02-H50): 1.58 Amps
 Odd contribution(H03-H49): 53.58 Amps
