## Consulting Report Breaker Trip / Fuse Blowing Investigation MCC / Blower Motors

### Introduction / Background

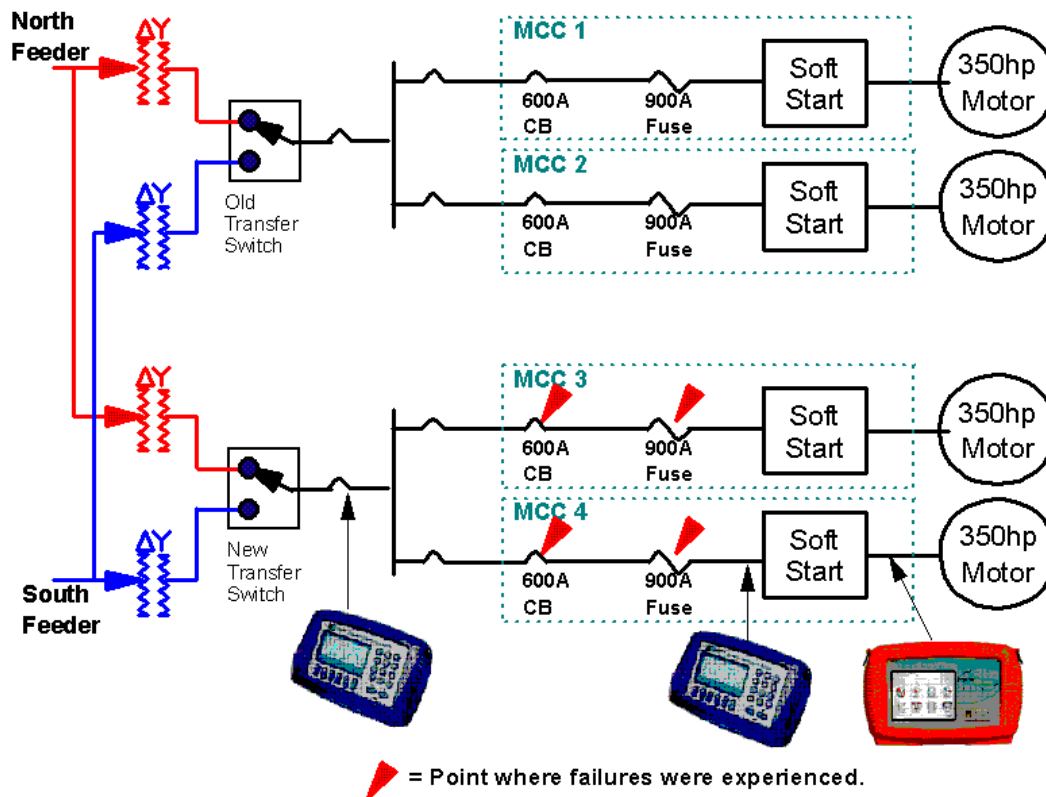
**Figure 1 - Simplified diagram of blower electrical distribution.**

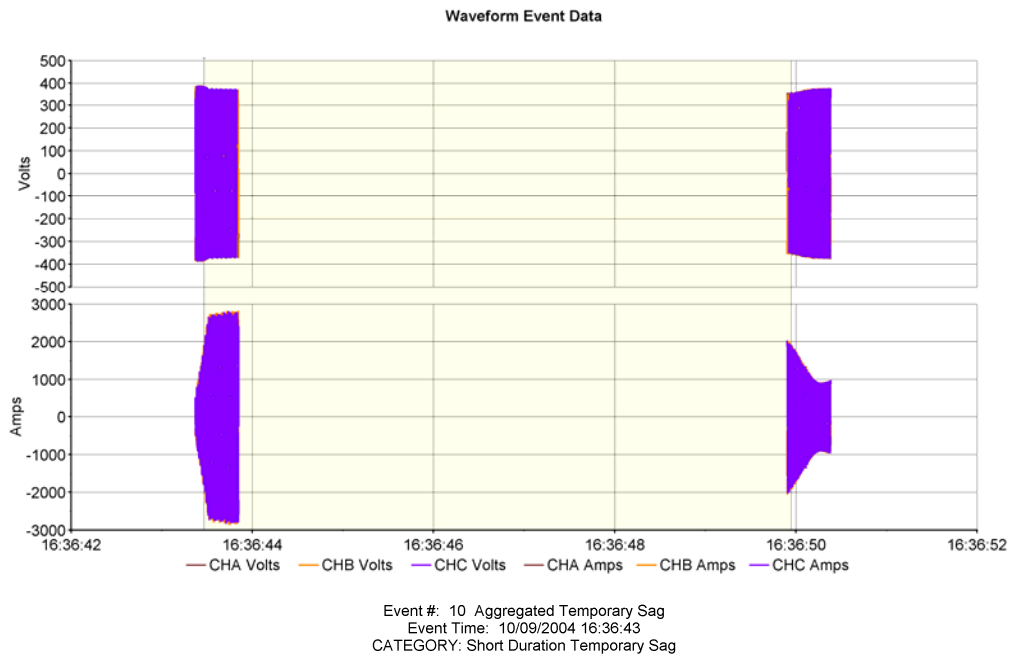
Figures 2, 3 and 4 show the waveform envelope and associated inrush voltage and current waveforms of a normal (successful) start-up of a second blower with one blower already operational.

**Figure 2- - Waveform envelop of normal successful start with a second blower already operating.**

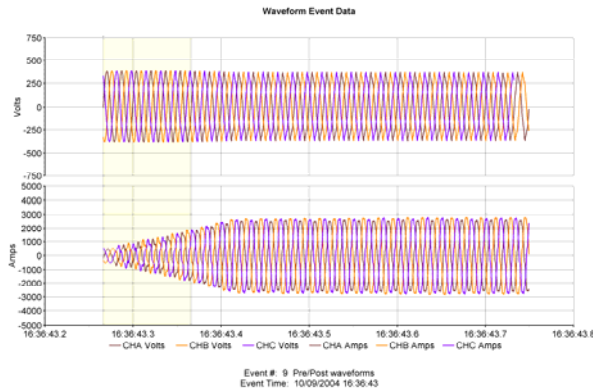
**Figure 3 - Inrush waveforms for start-up of blower--see figure 2.**

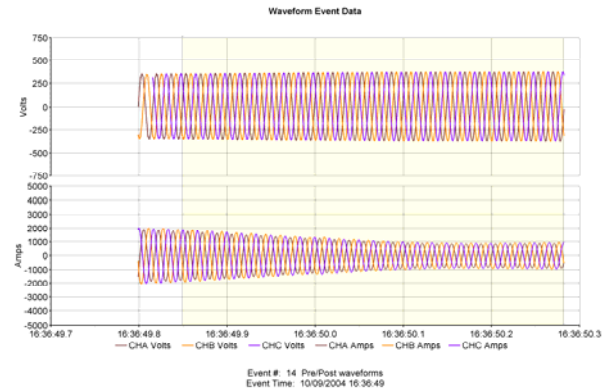
**Figure 4 – End of inrush for start-up of blower—see figure 2.**

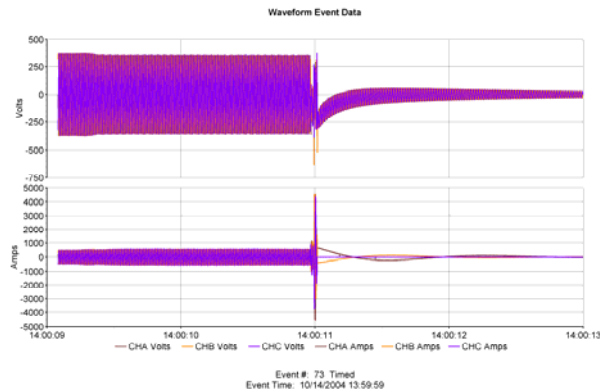
something causes the Automatic Transfer Switch (ATS) switch to transfer to the alternate (second) source. At the time that the ATS closes on the second source a current surge, well above the instantaneous setting of 3000A for the MCC 600A input breaker, is experienced causing the 600A breaker in the MCC to trip.

**Figure 9** Waveform envelop of MCC 4 soft-start output at time of breaker tripping—refer to figures 7 and 8.

**RECOMMENDATION:** (1) Correct the phase inconsistencies between the respective sources of the ATS. It is actually more like the phases were “rolled” (or rotated) as the correction involves all three-phases. The inconsistency could be in either of the sources (services) or the actual wiring of the ATS. While it is common practice to verify phase rotation it is no guarantee that the ATS inputs are wired with the proper phase relationships—as this experience demonstrates. Phase rotation should always be checked, and in addition a voltage reading should be made between corresponding phases of the respective sources—a near zero value should be obtained if the phase relationships are correct. In the case of the new ATS the readings of A to A, B to B and C to C were all in the 480V range indicating a phase relationship wiring problem. (2) Retest and document cycling of equipment in various modes following correction of ATS wiring.

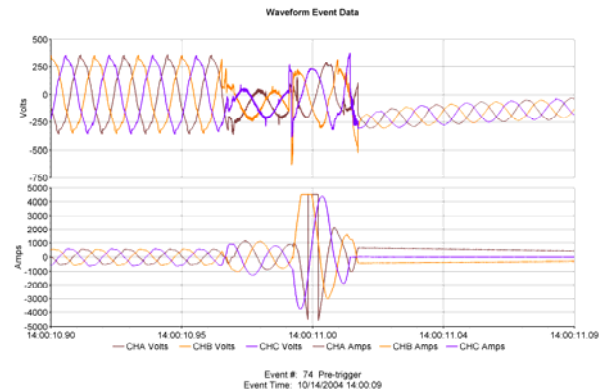
**Figure 10** – Detailed waveform recorded on MCC 4 at the output of the soft-start at the time of breaker tripping—refer to figures 7, 8 and 9.

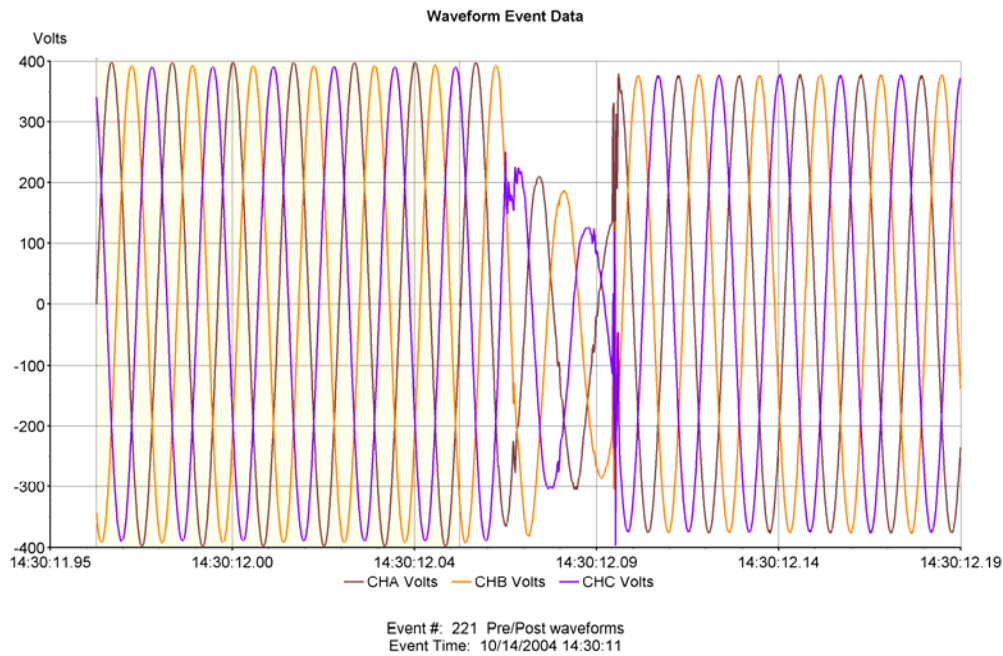
**Figure 11** – ATS return to preferred source approximately 30-minutes following blower failures at 1400Hrs.—refer to figures 7 through 10. The retransfer back to the preferred source was programmed option.

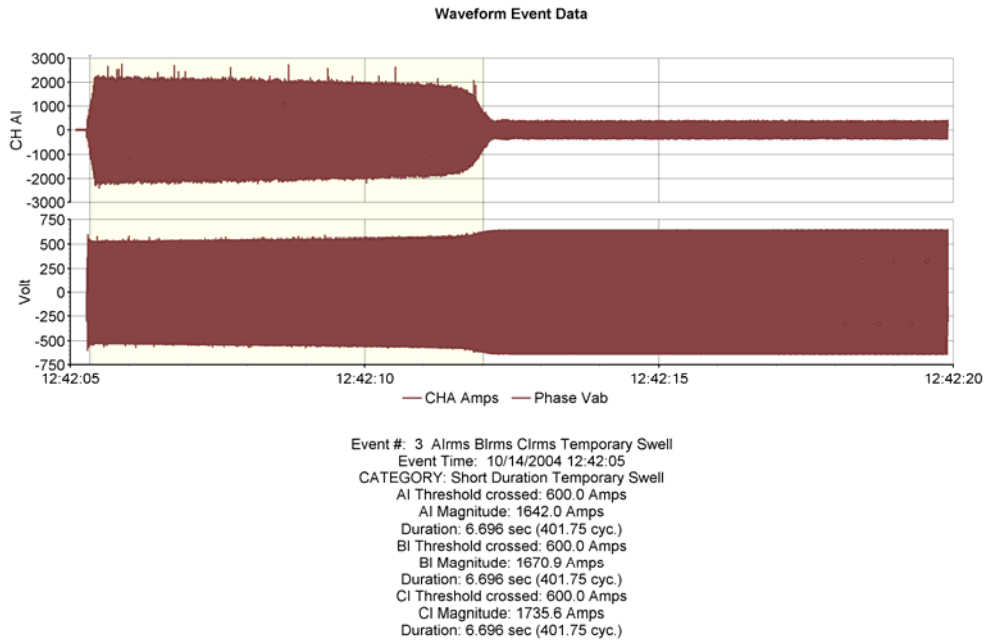
**Figure 14 - Waveform envelop for normal start-up of blower 4. Measurements taken at output of soft start.**

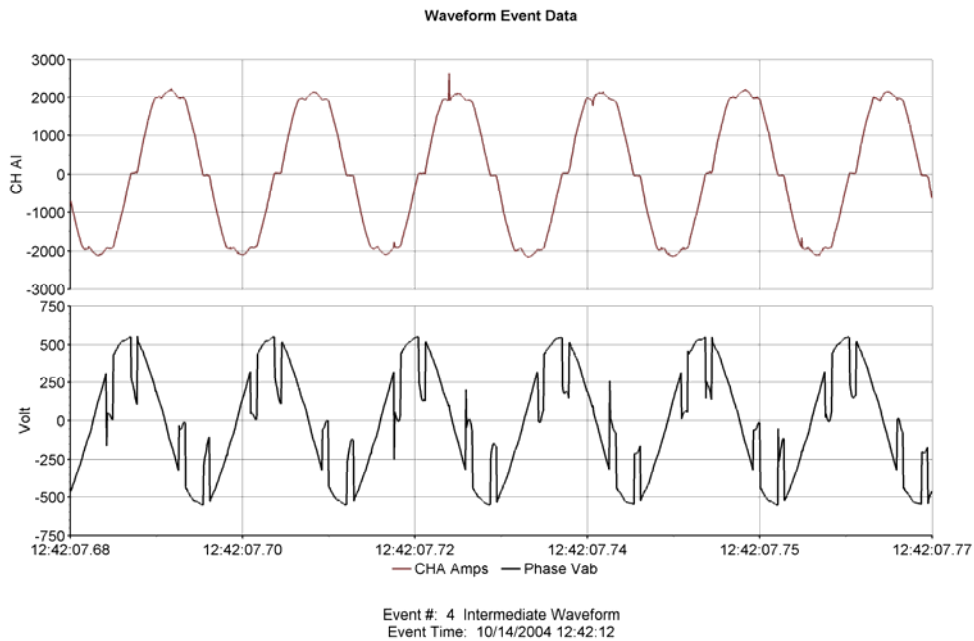
**Figure 15 - Current and voltage waveform during inrush with soft-start active. Measurement taken at output of soft-start.**

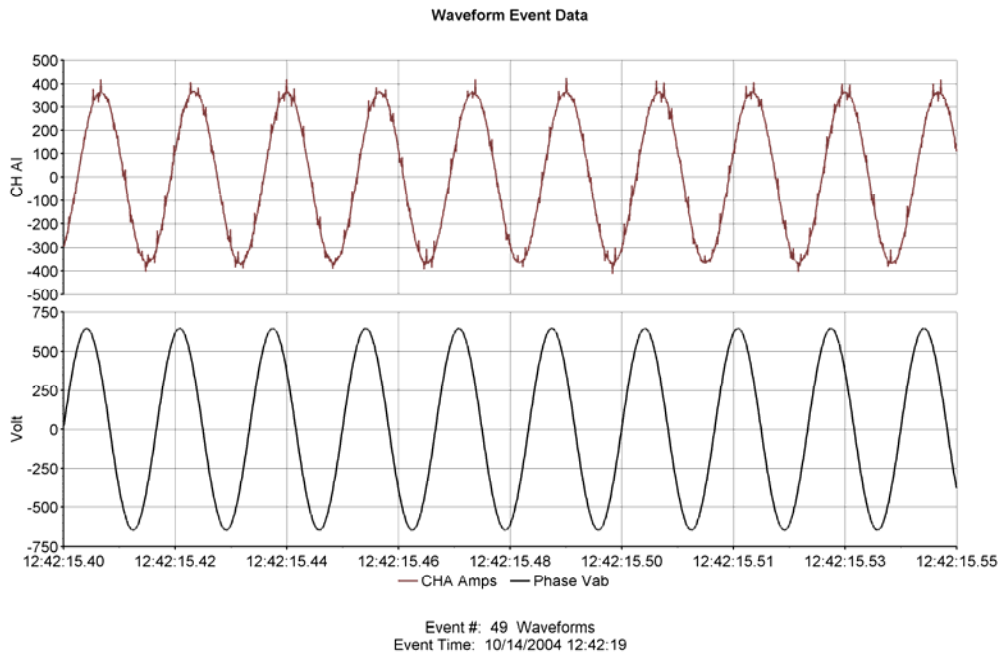
**Figure 16 - Current and voltage waveforms during normal blower operation after inrush and soft-start operation. Measurement taken at output of soft-start.**

**COMMENT:** The performance of the soft-start was documented, at the request of the client, as there was some initial concern that the problem may have been associated with “harmonics” at the output of the soft-start. There is a tendency “rush to judgment” and blame harmonics for most any problem that is not immediately obvious.
