**Consulting Report
 Noisy Transformer Problem Investigation
 OPM Office Building
 1000 Shellfish Drive, Somewhere Valley, CA**

Introduction

A 225KVA distribution transformer located on the 5th floor of 1000 Shellfish Drive is very noisy resulting in tenant complaints. PowerCET Corporation was requested to inspect and measure the electrical load on the associated transformer in an attempt to determine the cause of the excessive noise.

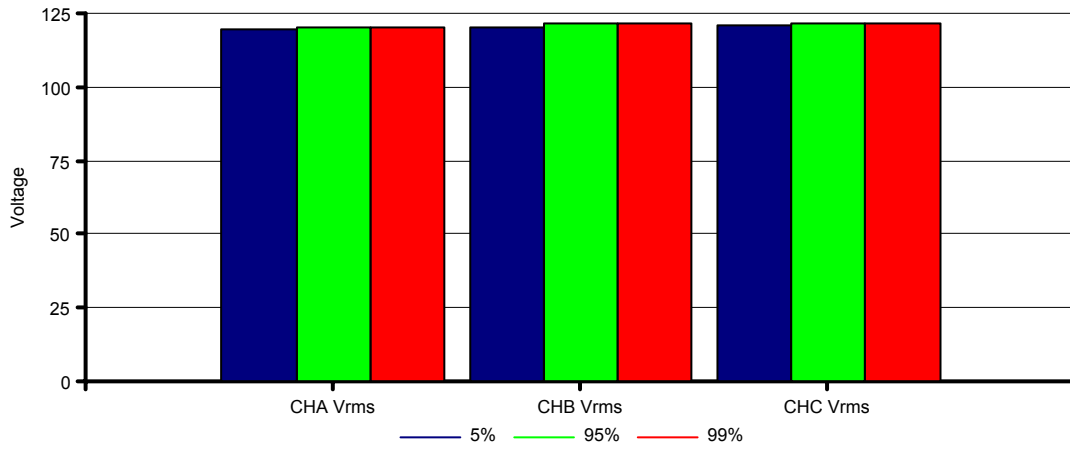
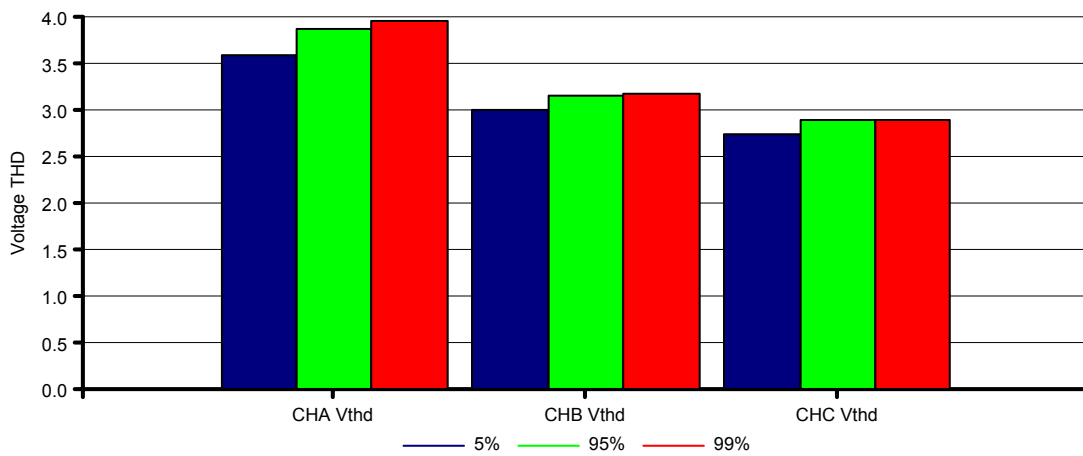
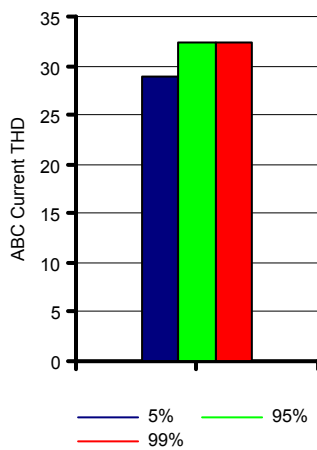
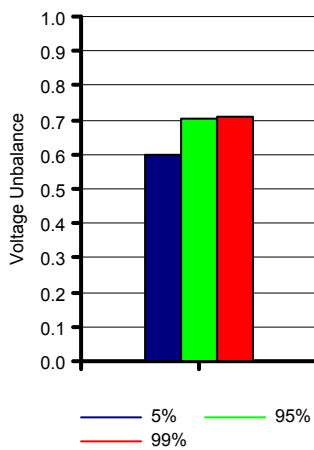
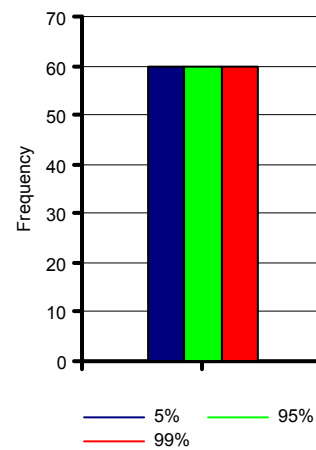
QUALITY OF SUPPLY SUMMARY GRAPHS

1. The transformer is very noisy but not over heating. The quality of supply graphs on the following page indicates normal voltage levels with harmonic distortion (THD) levels at acceptable levels.
2. The voltage harmonics range from 3% to 4% with Phase A the highest—which is consistent with the phase loading as phase A has more connected load.
3. The current harmonics range from 25% to 35% THD, which is not excessive and should not normally pose a problem. Figure 1 below shows the time plot for both voltage (VTHD) and current (ITHD) for the brief monitoring period.
